The Illustrious Lustron

A Guide for the Disassembly and Preservation of
America's Modern Metal Marvel

By
Cynthia Liccese-Torres
and
Kim A. O'Connell

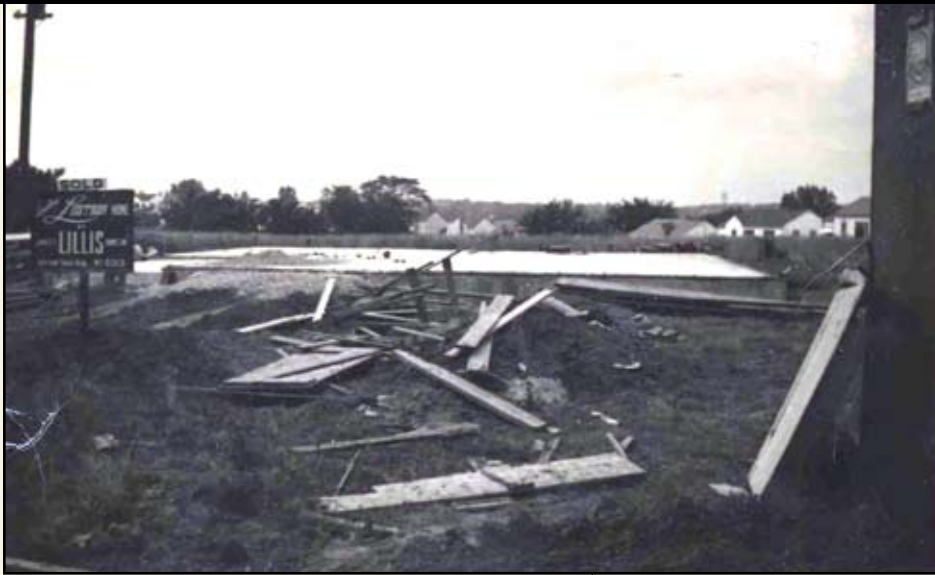
The foundation has been excavated and poured for the Ruble home (serial #775), located at 14 E. Porte Cimi Pas, Kansas City, Missouri. Image dated May 17, 1949. Note the local Lustron dealer's "sold" sign prominently displayed in the front yard.

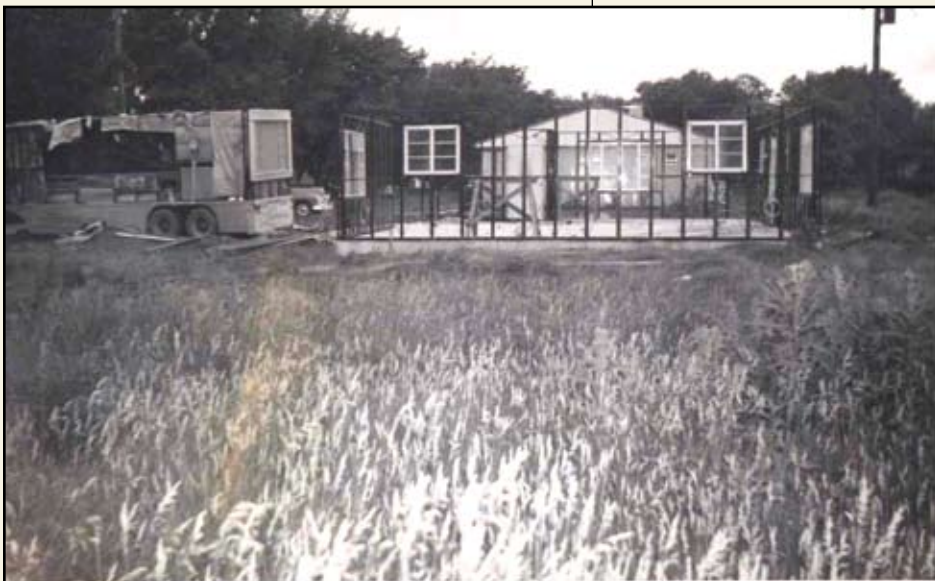
The foundation has set and the wall sections are being installed. Image dated June 13, 1949. In the yard, note the conveniently parked Lustron trailer, which would have been packed in the order needed at the building site. Another Lustron with the small square-shaped bedroom windows, typical of earlier models, already has been completed next door.

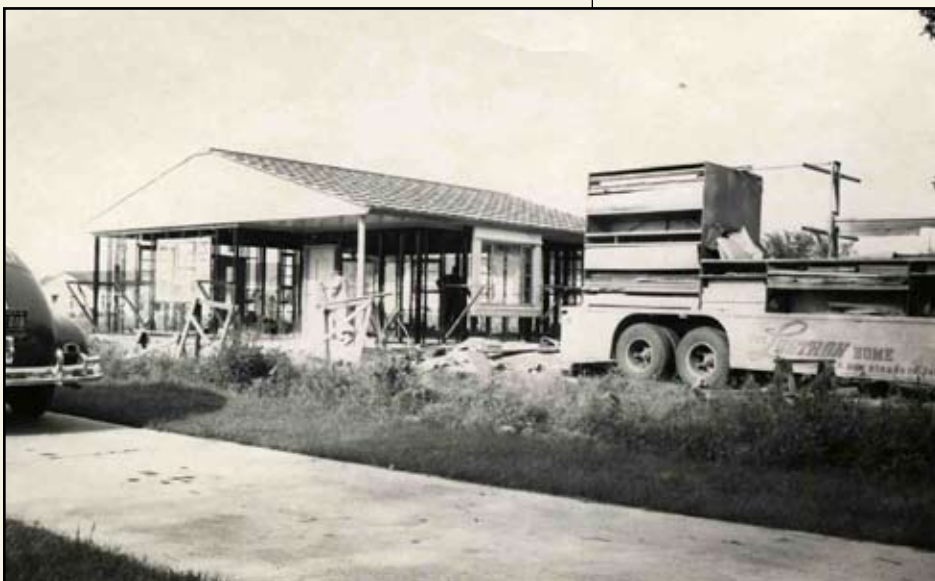
In just two days' time, all the wall framing is up and the roof trusses and panels in place. Image dated June 15, 1949.

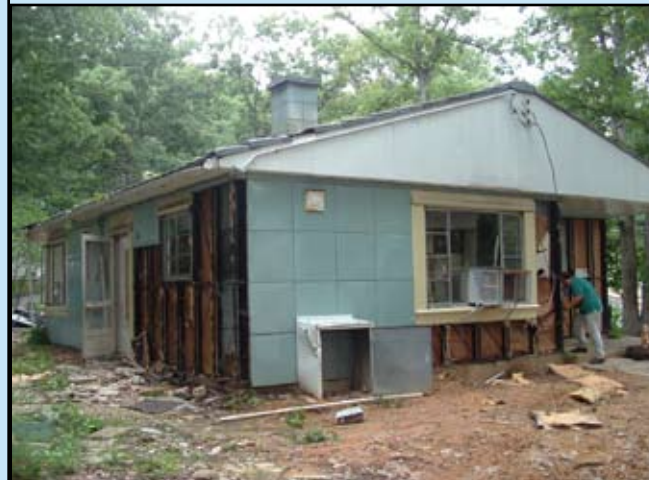
Rear and left side elevations, showing salvaged panels and exposed wall framing. —Cynthia Liccese-Torres, August 10, 2005

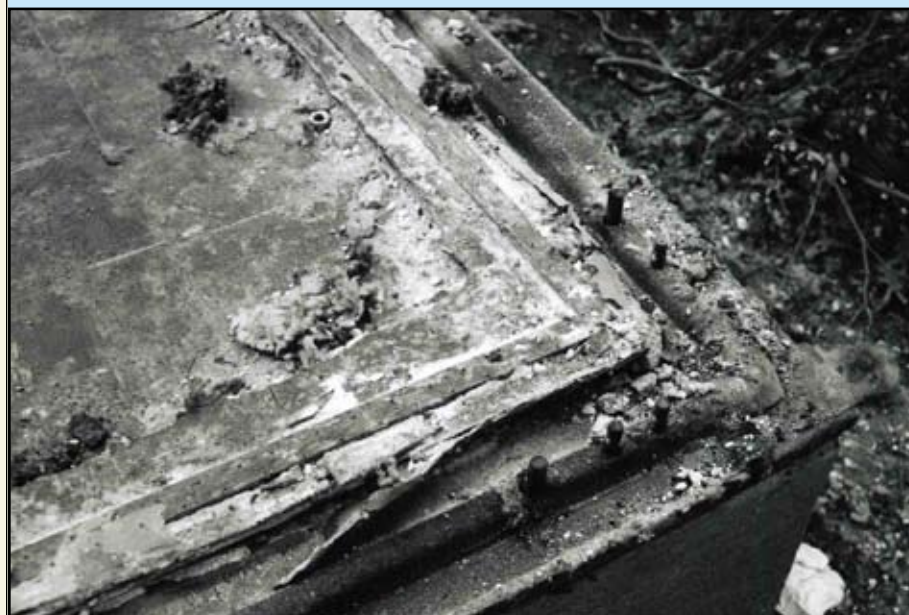
Detail of the metal tracking attached to the perimeter of the foundation where the wall sections were anchored. This tracking could not be salvaged from the Krowne Lustron site. —Cynthia Liccese-Torres, June 8, 2006

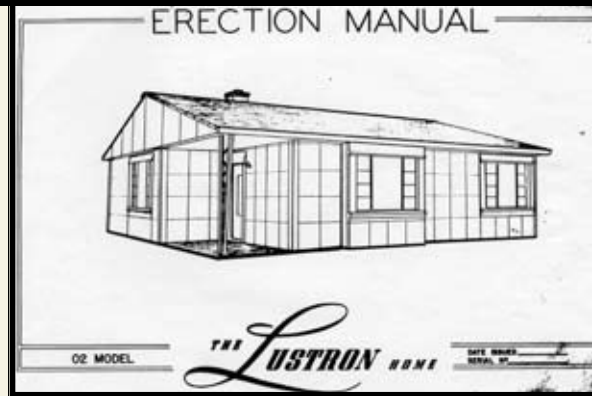
Front cover of the Lustron Erection Manual for the Westchester 02 model.
—Courtesy of the Arlington County, Virginia, Historic Preservation Program

Before lifting a single tool, the crew studied the official Lustron Erection Manual for the Westchester Deluxe model, a photocopy of which was stored in the County Historic Preservation Program's historical building files. (For other copies, especially of different models, check local libraries, historical societies, or the Internet.) The detailed construction manual outlines every aspect of construction

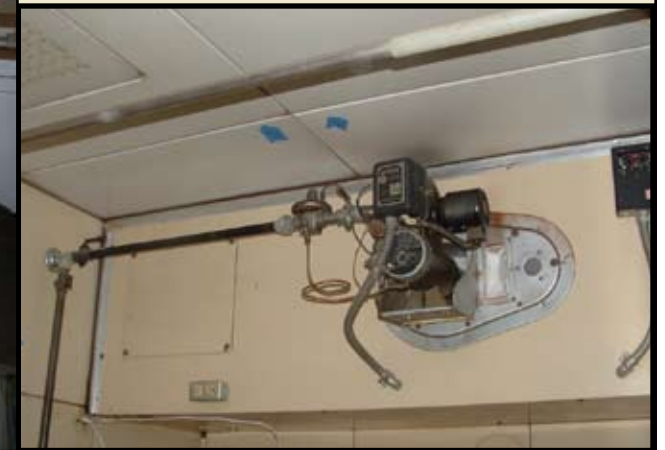
Original and still functional Gas-o-matic furnace surrounded by labeled interior panels.
—Marlene Terreros-Oronao, May 3, 2006

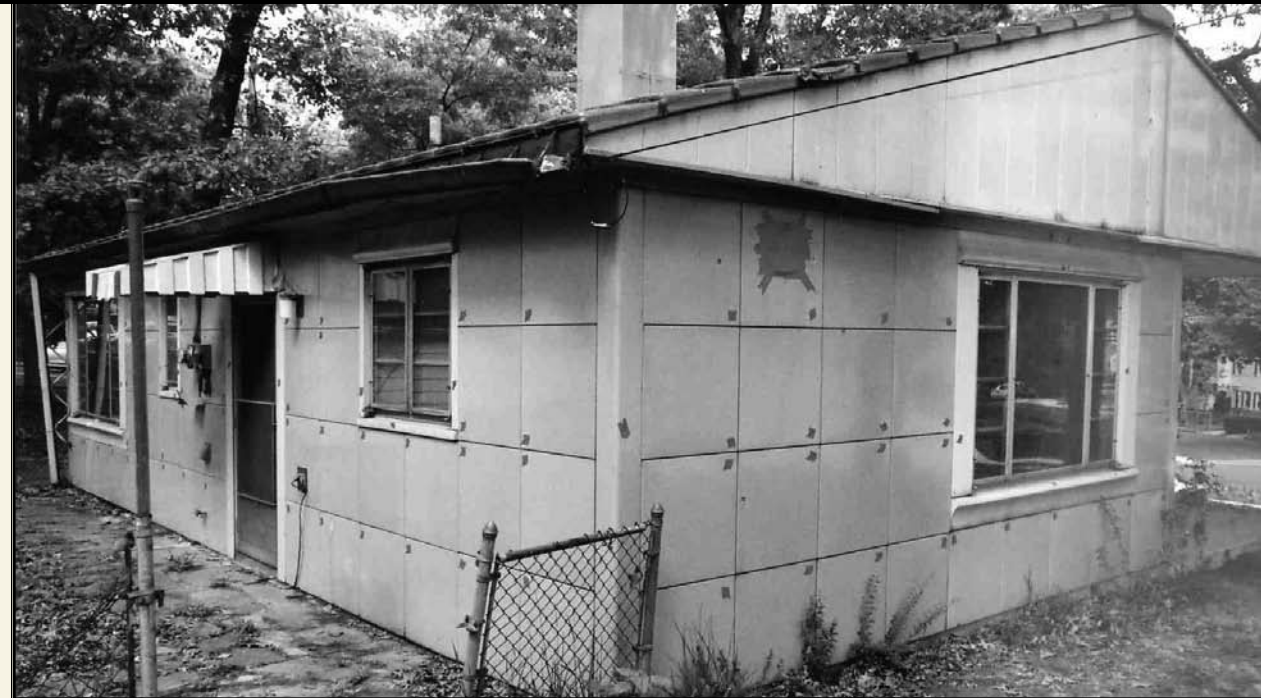
*Rear (west) and left (south) elevations, with most exterior panels and features labeled with blue tape.
—Victor E. Muniac, May 3, 2006*

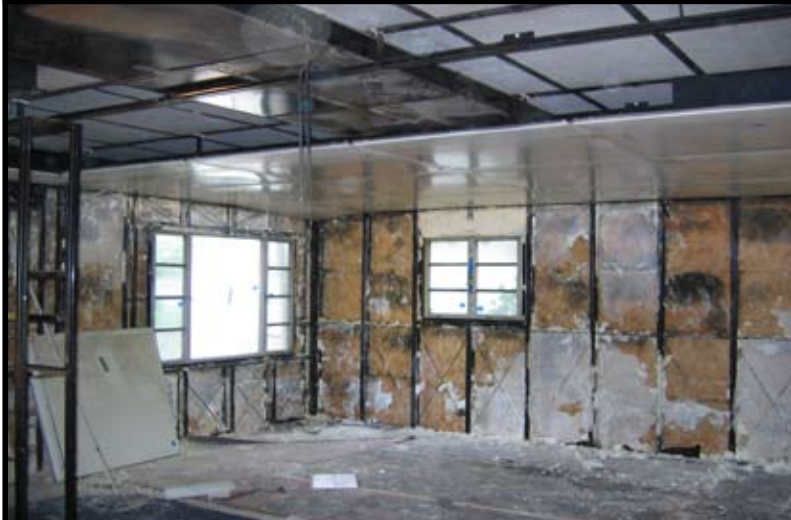
View of second bedroom looking northwest, with exposed wall framing, ceiling panels, plenum, and fiberboard insulating panels above. The plenum is the black rectangular box extending below the insulating panels and above the ceiling panels.
—Charles Craig, May 18, 2006

A critical step in the disassembly was dealing with the fiberglass insulation that was affixed behind the exterior panels and between the plenum and ceiling panels. The Krowne Lustron had dual layers of insulation—the original, thin layer attached to the back side of the panels, and a second, fluffier layer that was blown in by a subsequent house owner more recently, according to Bruce Ruble, a former owner who sold the house to Krowne in 2005.²⁴ To save time, reduce unnecessary clean-up of debris, and eliminate a considerable

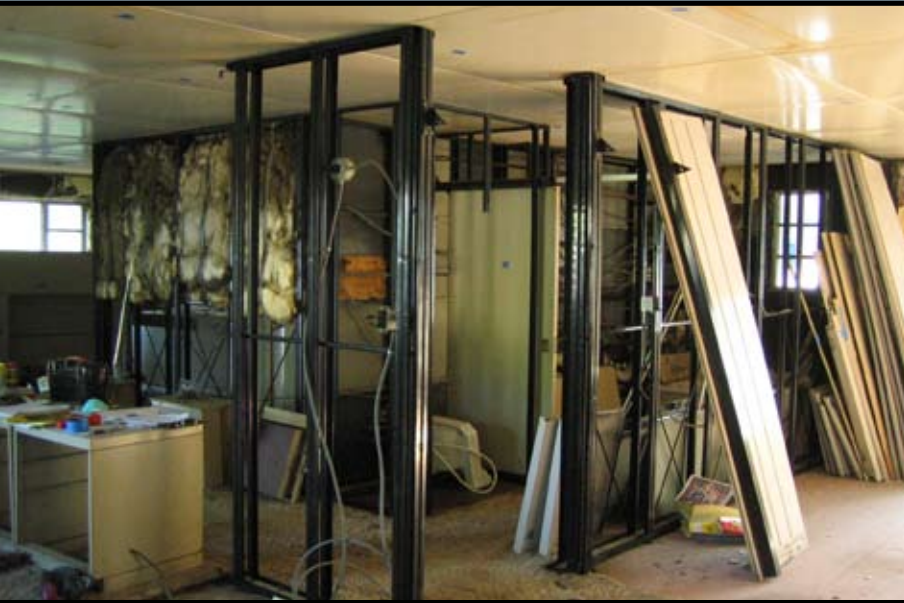
Interior paneling is partially removed, showing the wall sections comprising the bathroom, hallway, and utility room.
—Tom Dickinson, May 2006

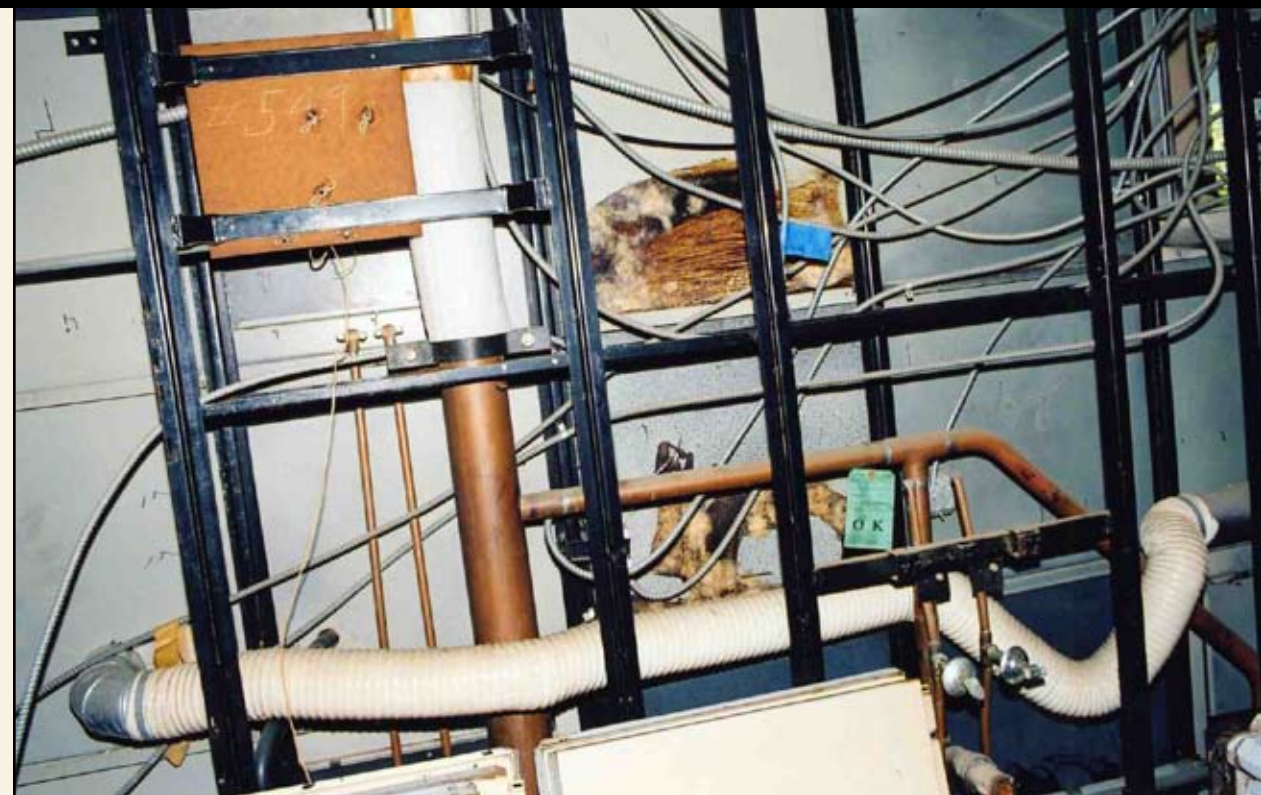
*View of original pipes and wiring behind service wall between the bathroom and utility room; note house serial number #549 written in white in upper left and the original green inspection tag from the Lustron factory dated May 9, 1949.
—Victor E. Muniec, May 10, 2006*

bathroom and the utility room, which hid the wires and mechanical systems used in the house. The tag was titled “Lustron Quality Control, O.K. Stock Tag” in the upper left-hand corner, then signed and dated by the inspector at the bottom. The tag also indicates the house’s lot number, which corresponds to the individual serial number (in this case #549). This was the only such tag found during the disassembly, though it is hoped that future Lustron disassembly crews may discover similar tags.

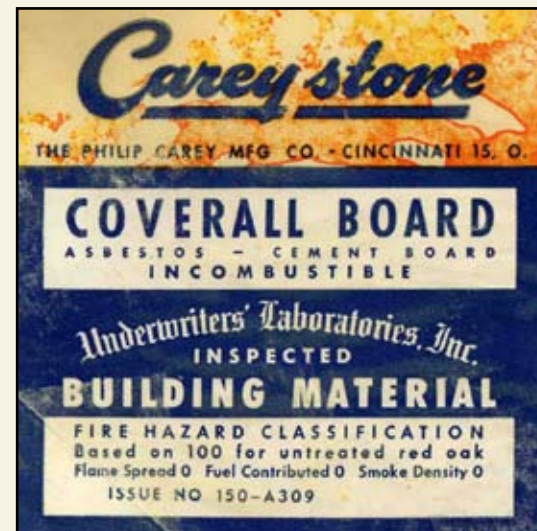
Original label from asbestos board above ceiling panels and below the plenum.

The cement board asbestos panels affixed above the ceiling panels were laid in sequence and held in place with strips and wing nuts, Phillips says, which were often rusted through from the water vapor caused by the radiant heating system. “I would say we used about eight cans of WD-40 when we went through and took off the ceiling panels,” Phillips says. “So we went through and sprayed every one of those panels ahead of time. I wouldn’t think they should ever use the asbestos panels again [in a restored Lustron, for instance]. The air is blowing all through that, so if it’s going to pick anything [toxic] up, it’s going to get into the air.”²⁵ Because of their concerns about the material, the crew disposed of the panels and lining at a special hazardous waste landfill in Lorton, Virginia.

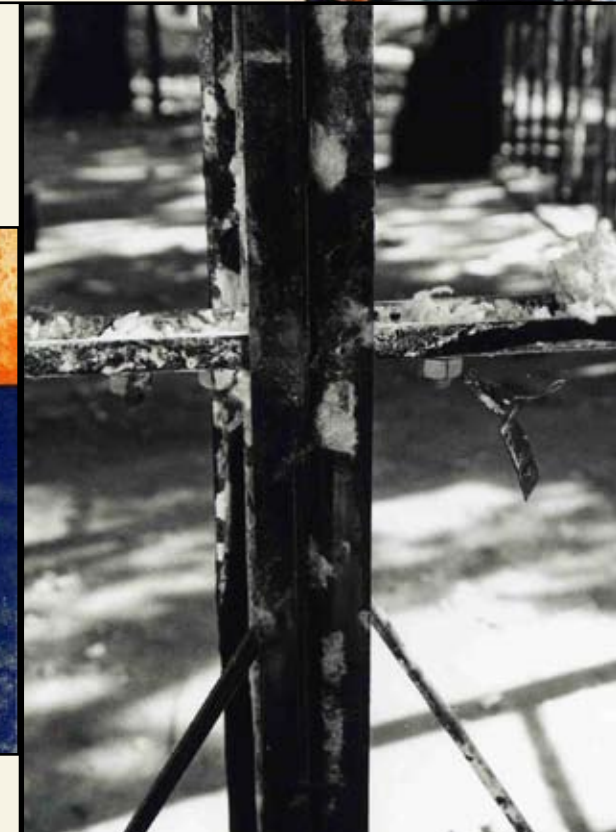
*Detail of structural framing with metal tag identifying wall section.
—Cynthia Liccese-Torres, June 6, 2006*

Small rectangular black metal tags, also attached at the factory, were found throughout the house on each wall section and affixed by a thin metal wire. The numbers on the tags corresponded to each wall section as labeled in the Erection Manual. Also of interest was an intact label from one of the fiberboard panels located above the ceiling panels. It bears the name “Careystone” at the top, manufactured by the Philip Carey Manufacturing Company in Cincinnati, Ohio. The label identifies the material as “Coverall Board,” an asbestos and cement board product. Other future Lustron disassembly projects may reveal similar or other tags and labels, which should be documented and saved so that others may be made aware of the types of original Lustron

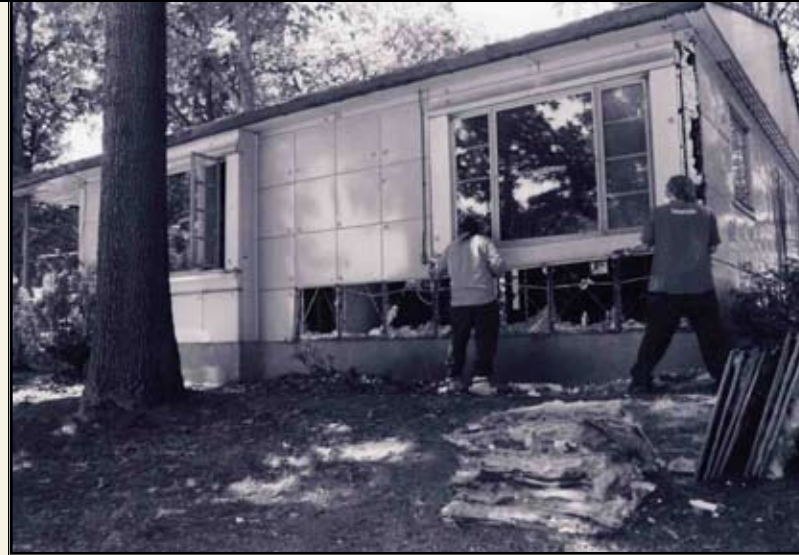
Removal of the first exterior panels on the front elevation; note the pile of fiberglass insulation from the panels stacked on the front lawn.
—Victor E. Muniec, May 2006

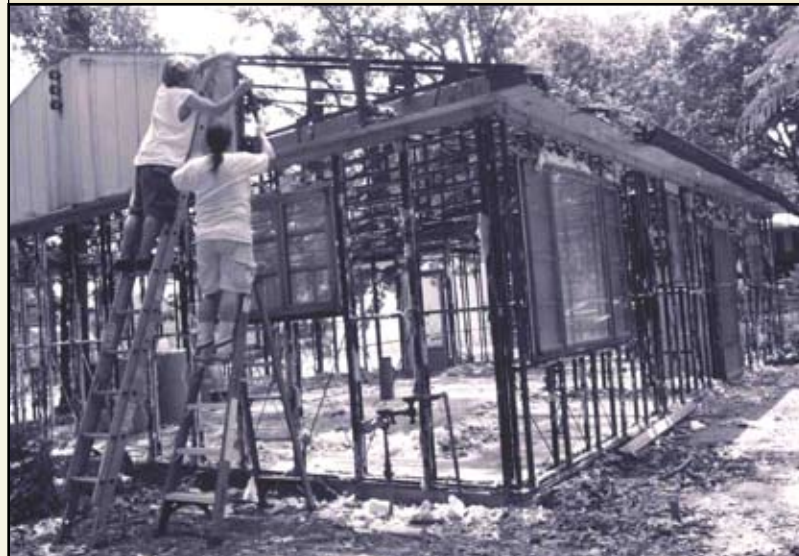
Removal of vertical panels on gable end of right (north) elevation.
—Victor E. Muniec, May 2006

Perhaps the single biggest challenge during the disassembly of the Krowne Lustron was the abundance of rust, especially in the gable ends of the house and in the bathroom. On the gable ends, eight vertical panels go across the space, with a riveted strip covering the seam with the wall structure where the vertical pieces interlock with the soffit underneath. When the crew removed the riveted strip, the panels were entirely rusted, as were some of the soffit and brackets. “When we took that strip off, you could see that it was completely a mess,” Phillips says. “[If this were to be repaired,] we could get wider molding and probably sink some screws through it, and that way it could cover the rust and still be intact.”²⁶

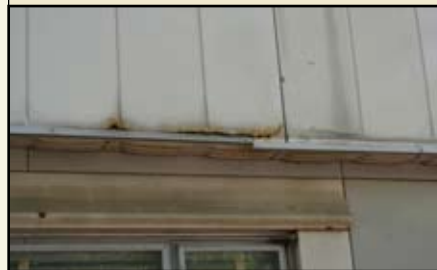
Detail of rusting at base of vertical panels along the gable ends.
—Todd Zeiger, May 3, 2006

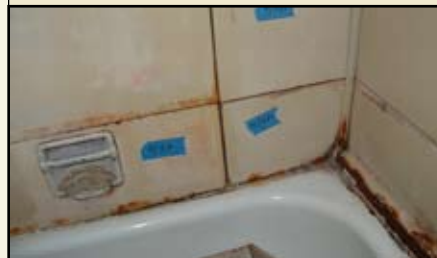
Bathtub rust.
—Marlene Terreros-Oronao, May 3, 2006

Unfortunately, rust, asbestos, and fiberglass insulation all posed problems during the deconstruction. As a result, not all of the original house components could be saved. In the bathroom, the bathtub area was covered in the inevitable rust

that comes with metal’s constant exposure to and contact with water. The curved metal panel pieces that rested on the top edge of the bathtub were rusted out and

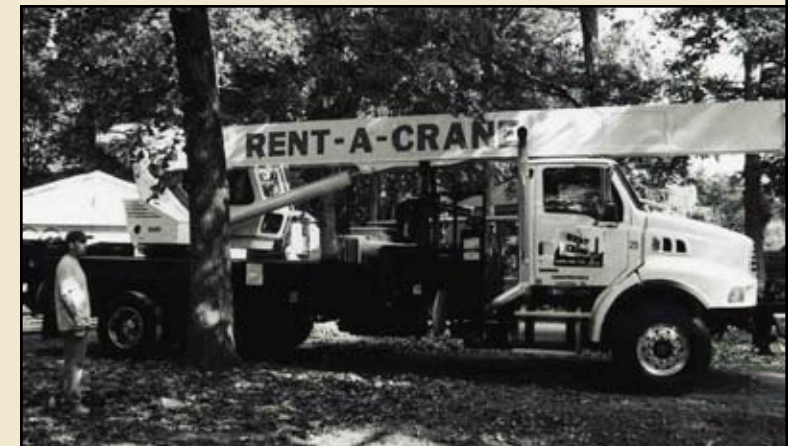
The crane gets situated in the driveway in preparation to remove the roof trusses.
—Cynthia Liccese-Torres, June 8, 2006

possible during the disassembly. Using the crane, the crew supervised the lifting of all the roof trusses and wall sections off the house, and then guided the pieces into piles for loading in the trailer. Then, the crew used a mini-excavator to leverage these pieces onto the truck. The crew encountered some difficulties, however. First, once the first truss was removed, the next few fell over like dominoes. It took the crew some time to readjust the fallen trusses and loosen their screws in preparation for being lifted off. Also, the mini-excavator could get the trusses into the truck only so far, so the crew had to push, pull, and adjust them inside the rest of the way, a difficult process that resulted in some pieces getting slightly bent. Frank Phillips is confident that those pieces can be straightened out again before reassembly.

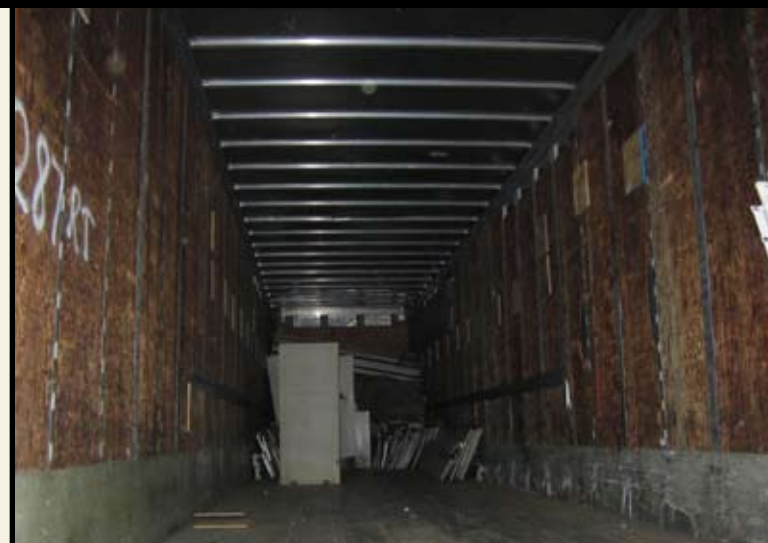
The first of the interior house components stored away in the trailer.
—Tom Dickinson, May 2006

“When you don’t take apart the trusses, they are 35 feet long, so they take up the bulk of the truck,” Phillips explains. “If you had stood the trusses up, they would have taken up half the truck, so we laid them down flat, and that’s where it really got tough. But they all fit on top of each other.”²⁹ The crew used plastic wrap material, corrugated cardboard, and even carpeting from the house to wrap windows and

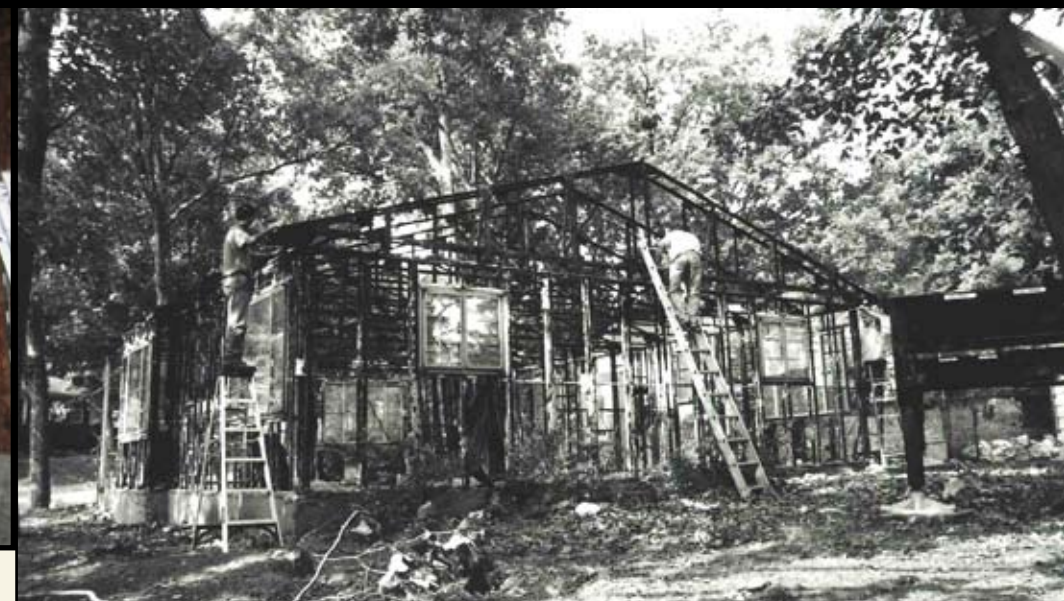
Securing the first roof truss to be lifted by the crane along the northern edge of the house. This process was made easier by three crew members – one on each end to loosen the corner bolts and one in the middle to secure the truss to the crane anchor.
—Cynthia Liccese-Torres, June 8, 2006

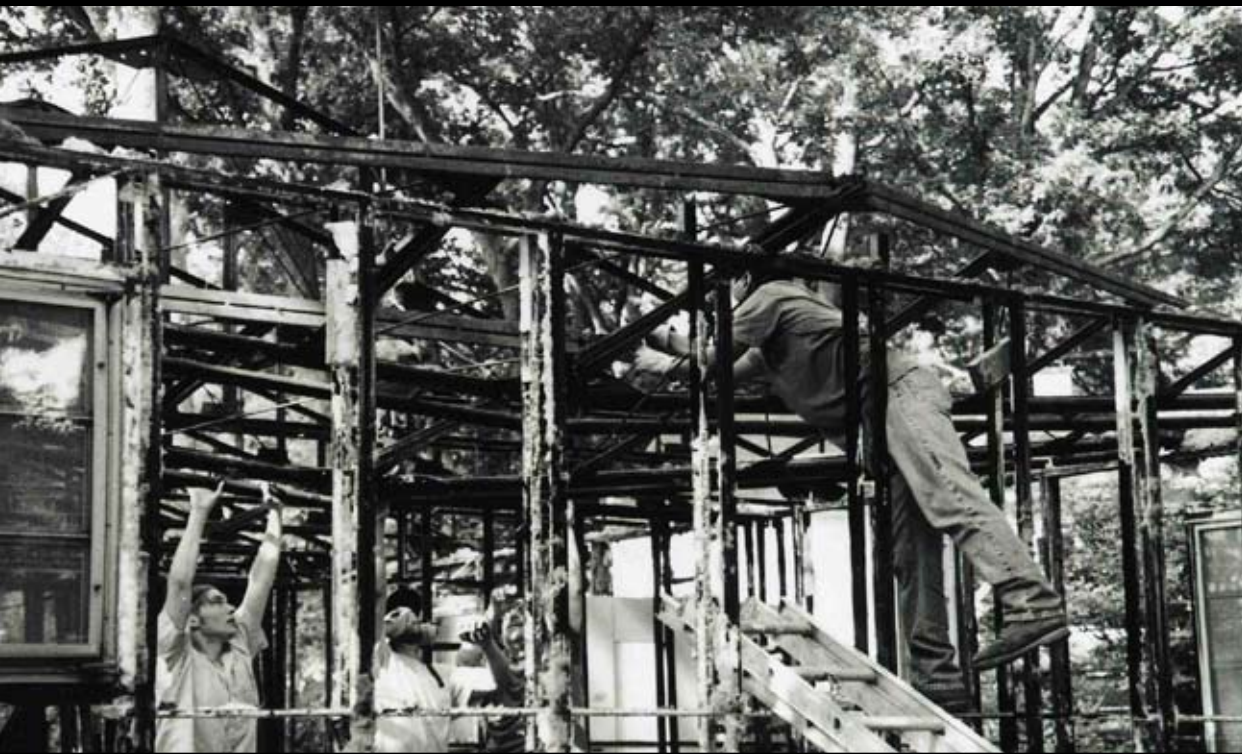
*The whole crew adjusts the fallen roof trusses that collapsed upon removal of the first truss.
—Cynthia Liccese-Torres, June 8, 2006*

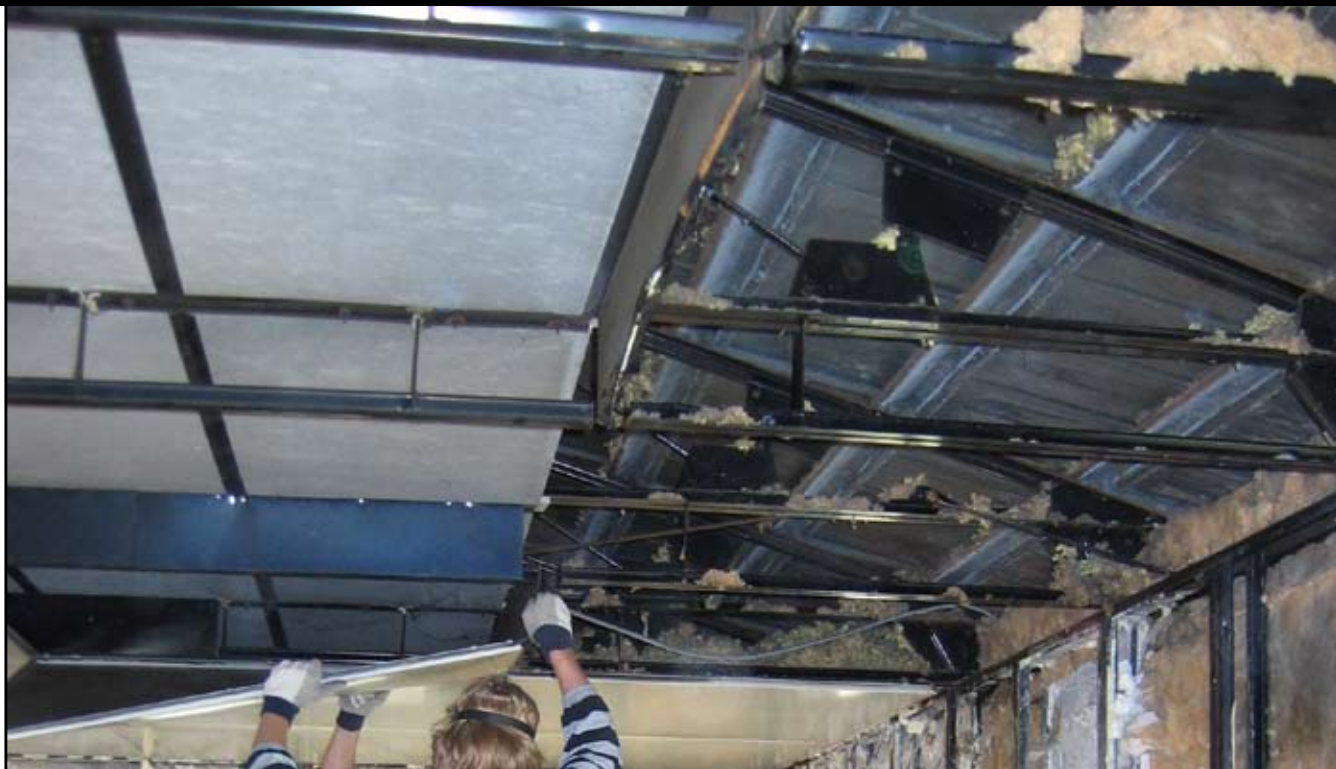
*Removal of ceiling panels, looking north towards the master bedroom.
—Charles Craig, May 18, 2006*

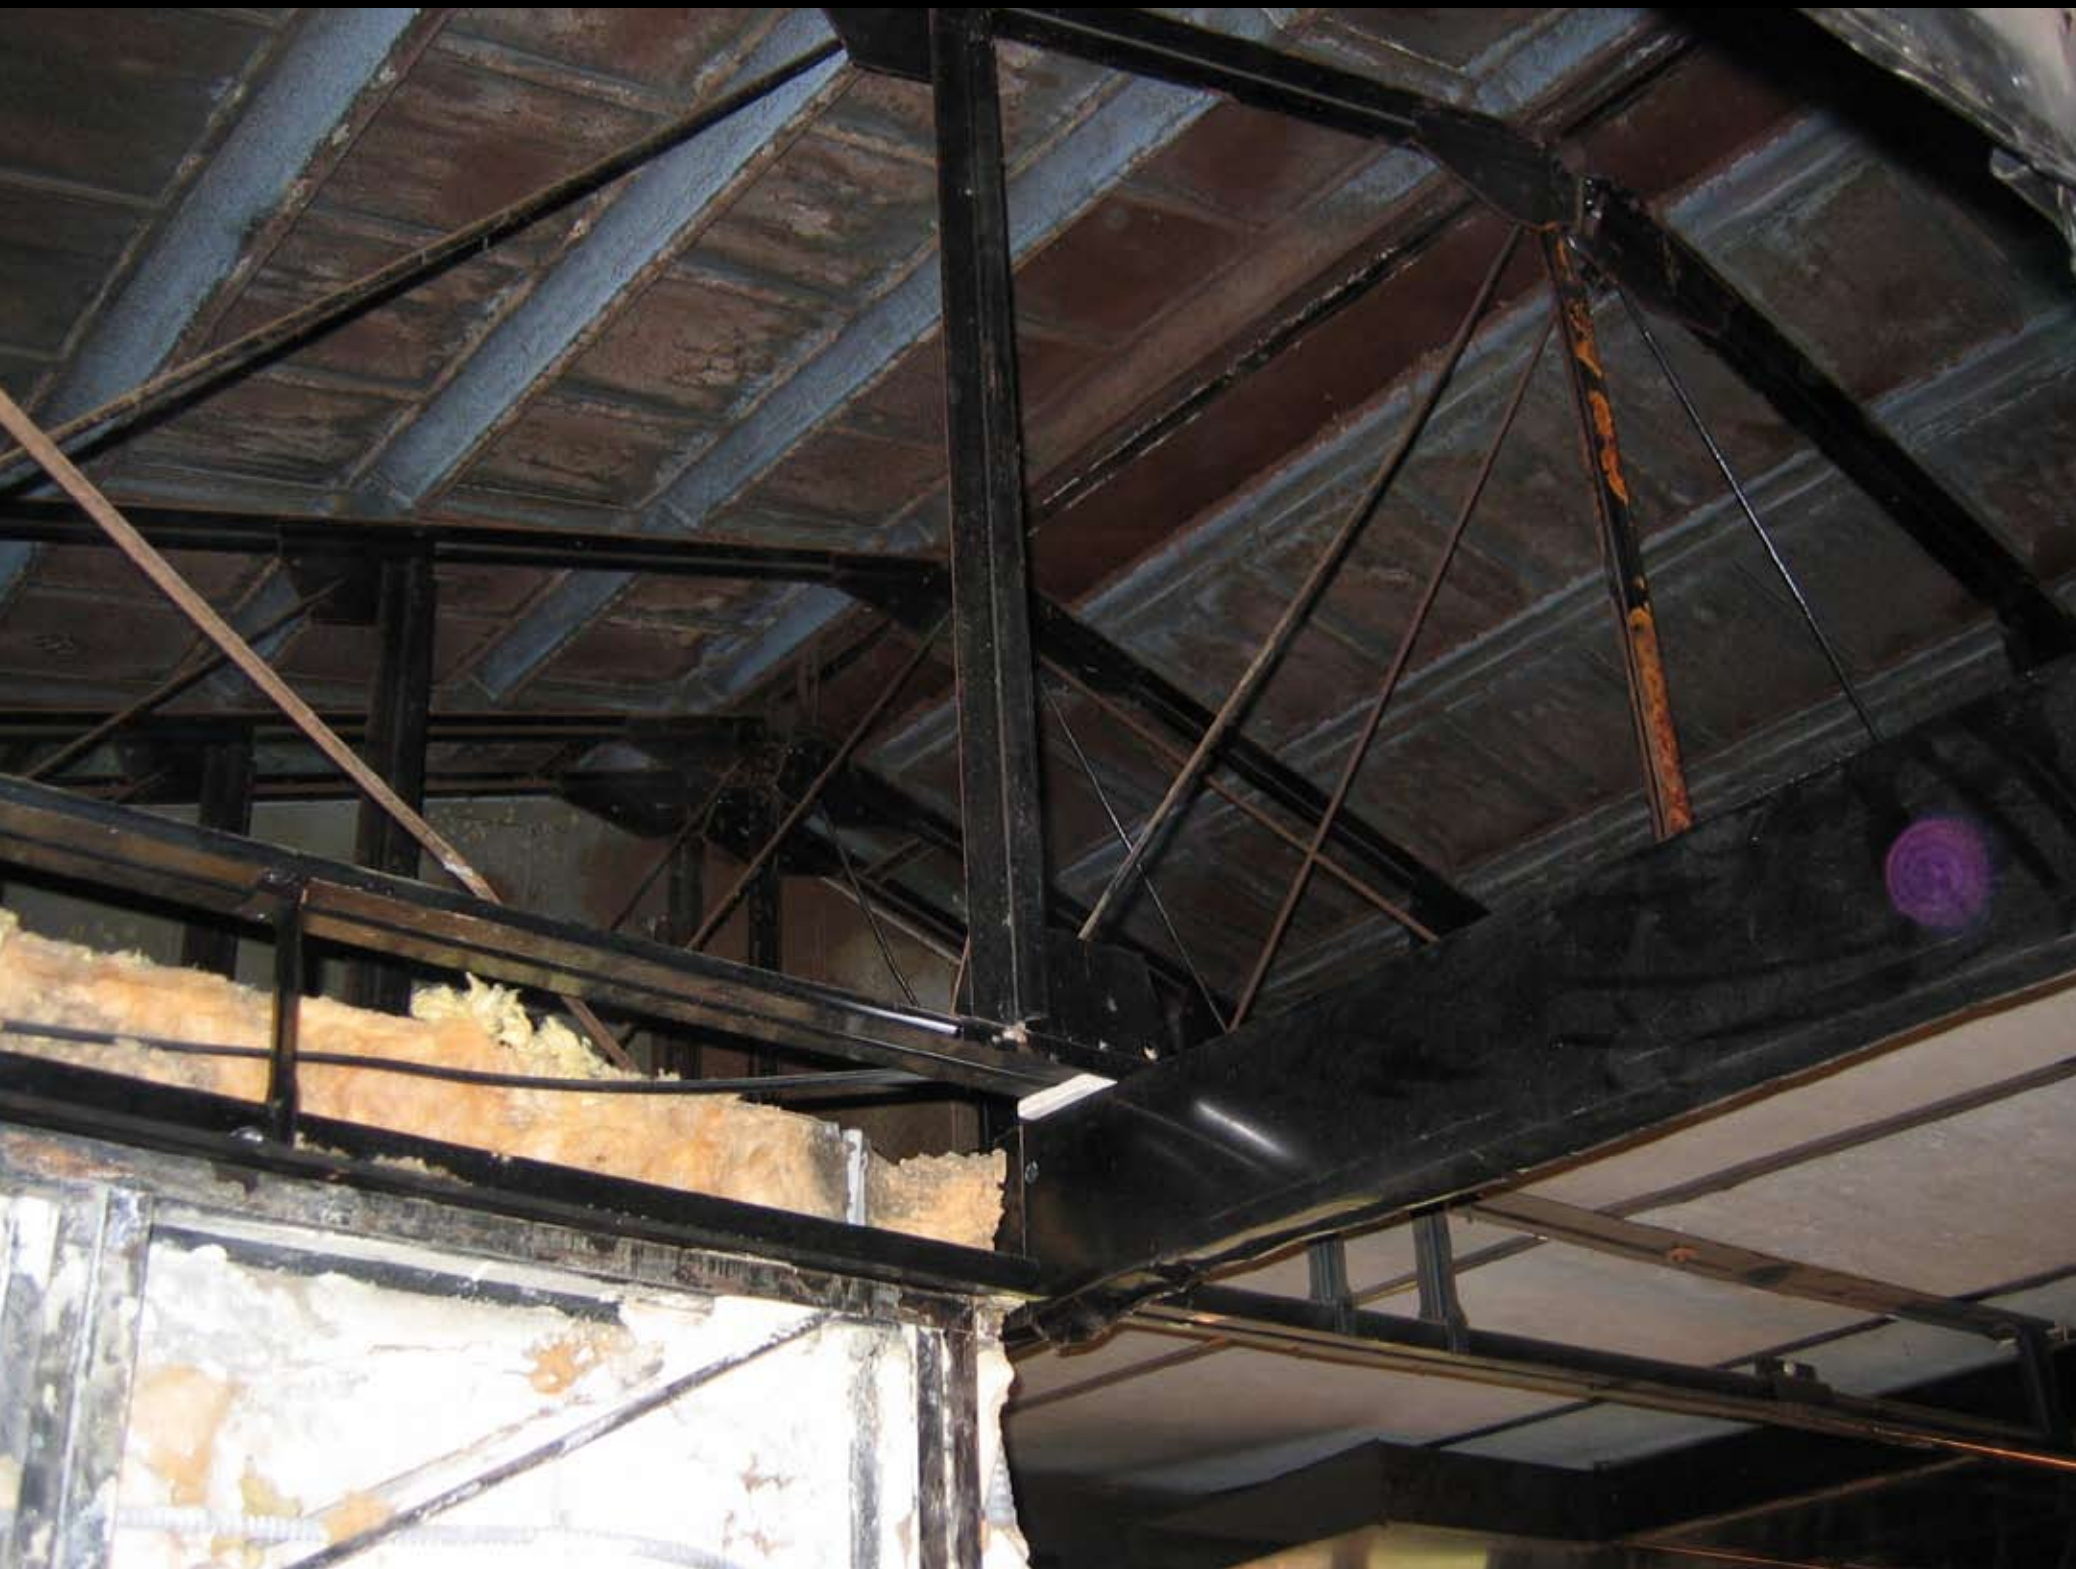
*Detail of exposed roof trussing and underside of roof panels.
—Charles Craig, May 18, 2006*

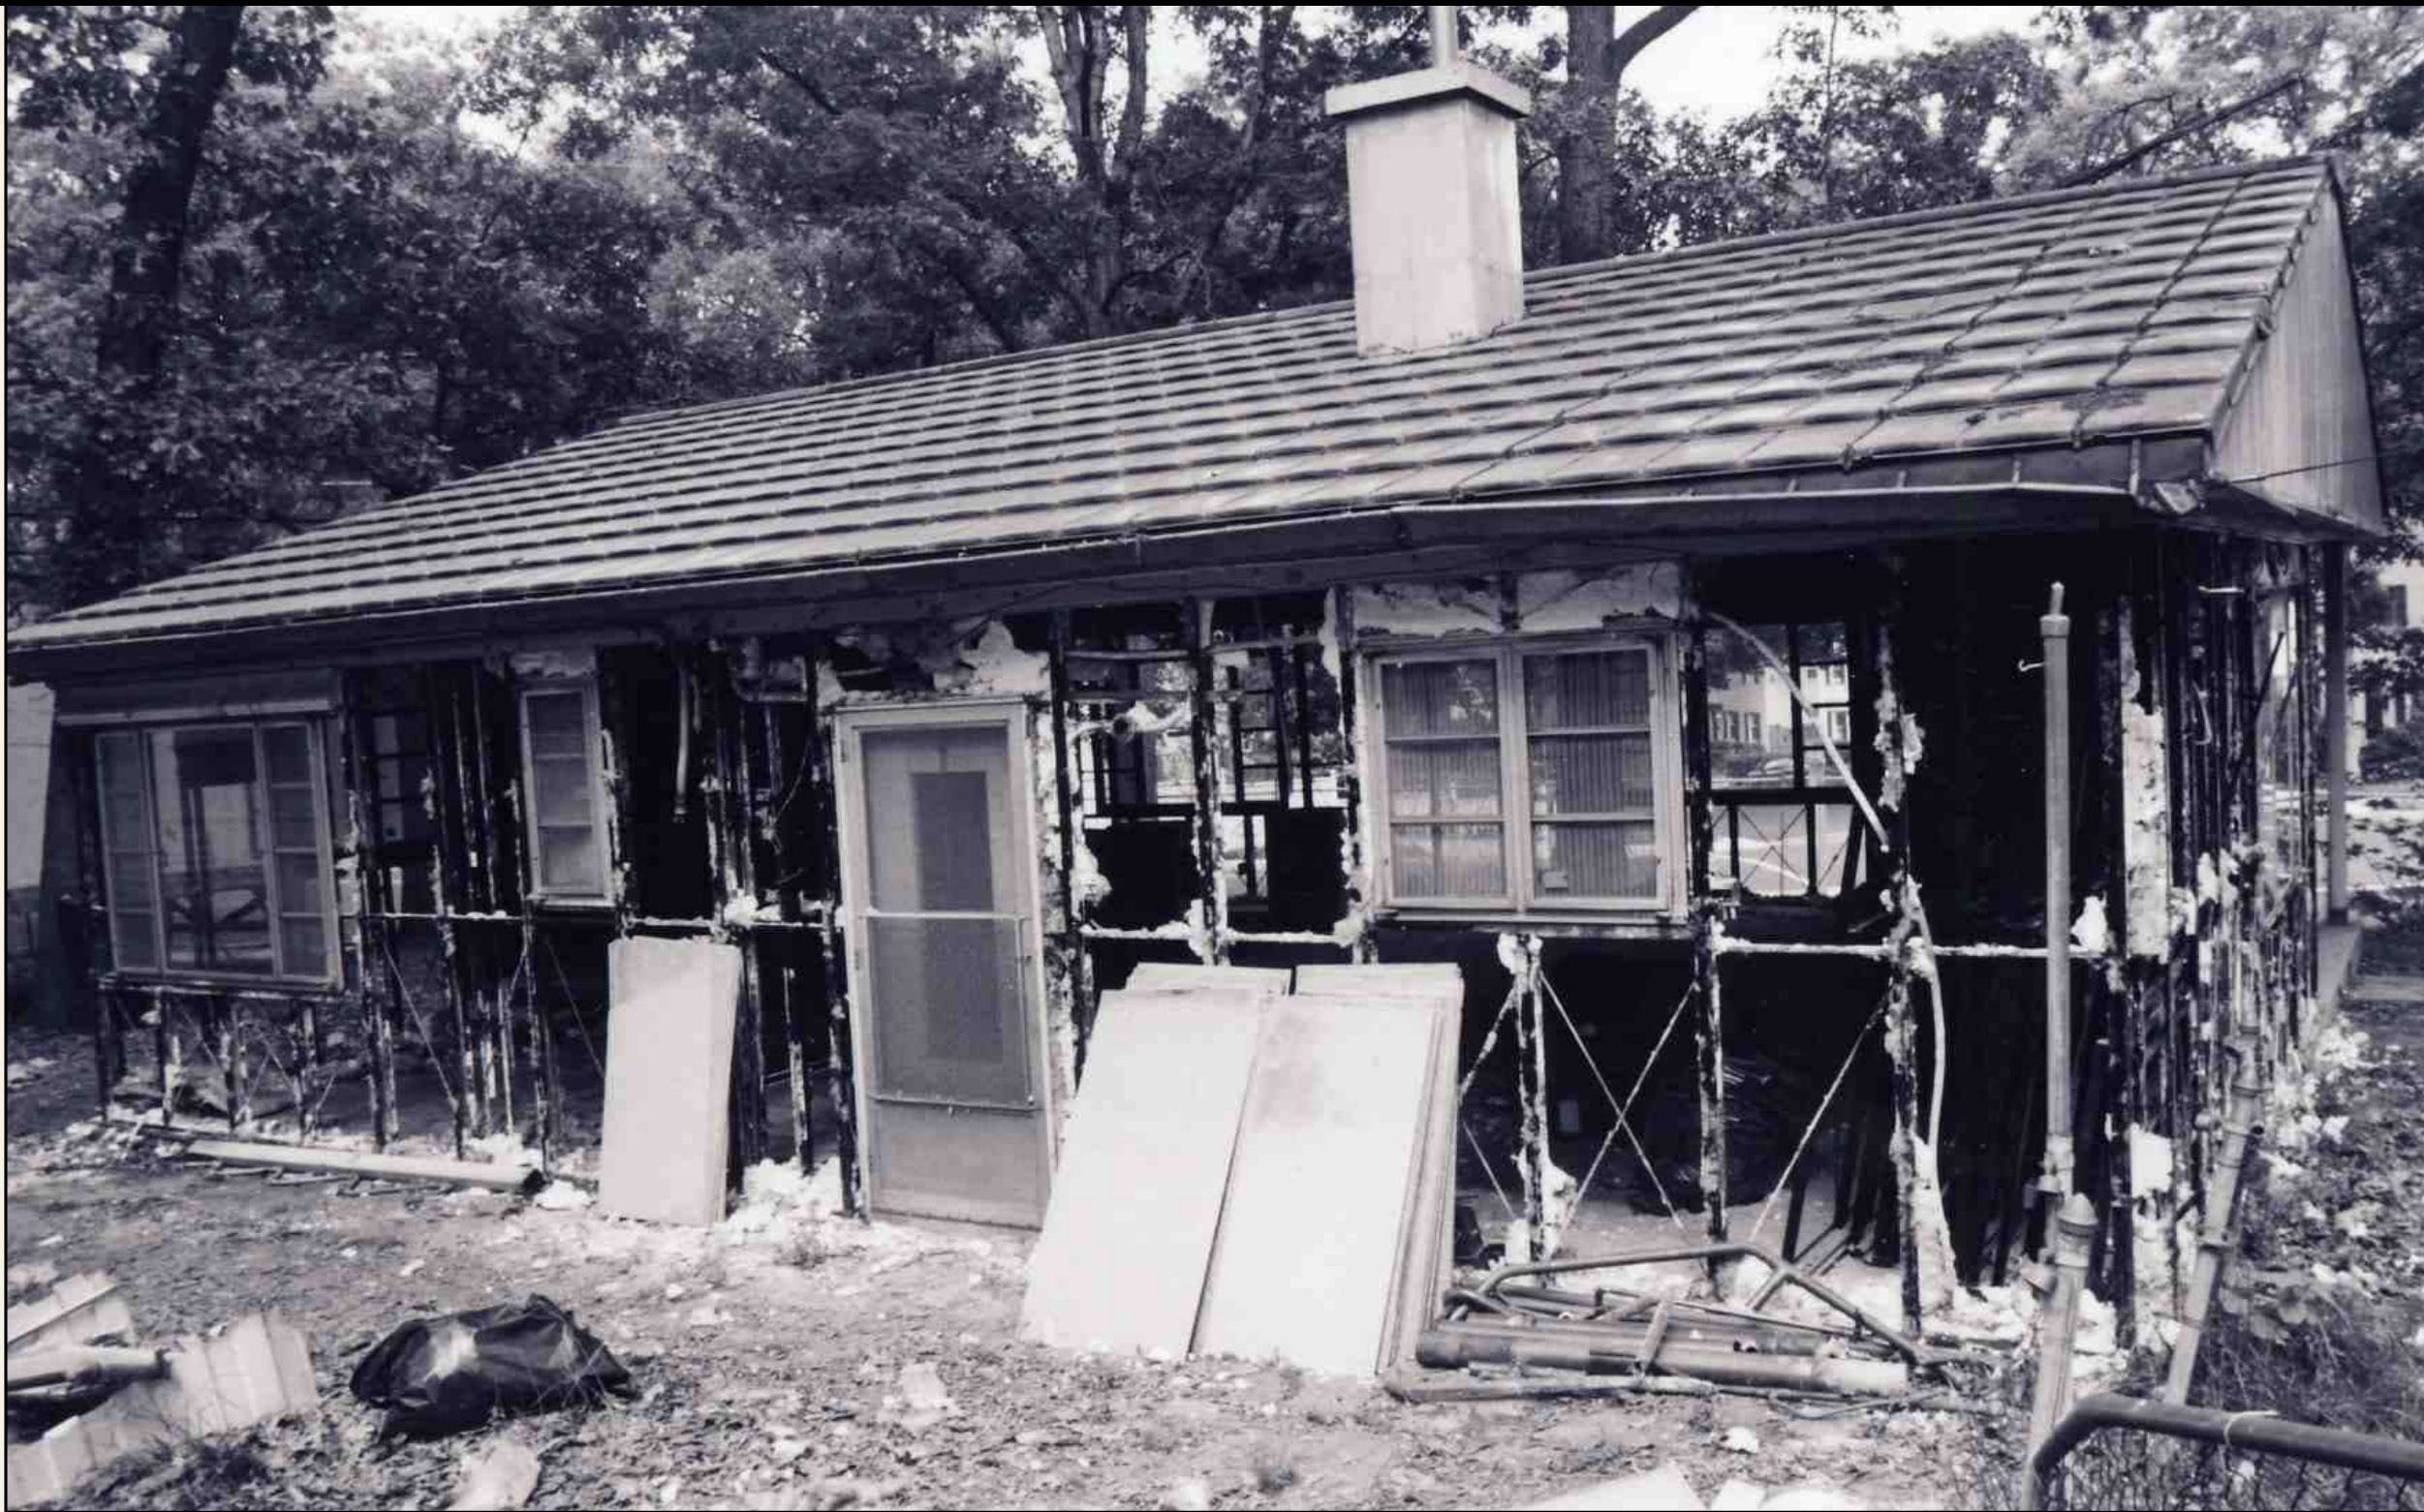
*View of rear (west) elevation with all exterior panels and insulation removed.
—Victor E. Muncie, May 2006*

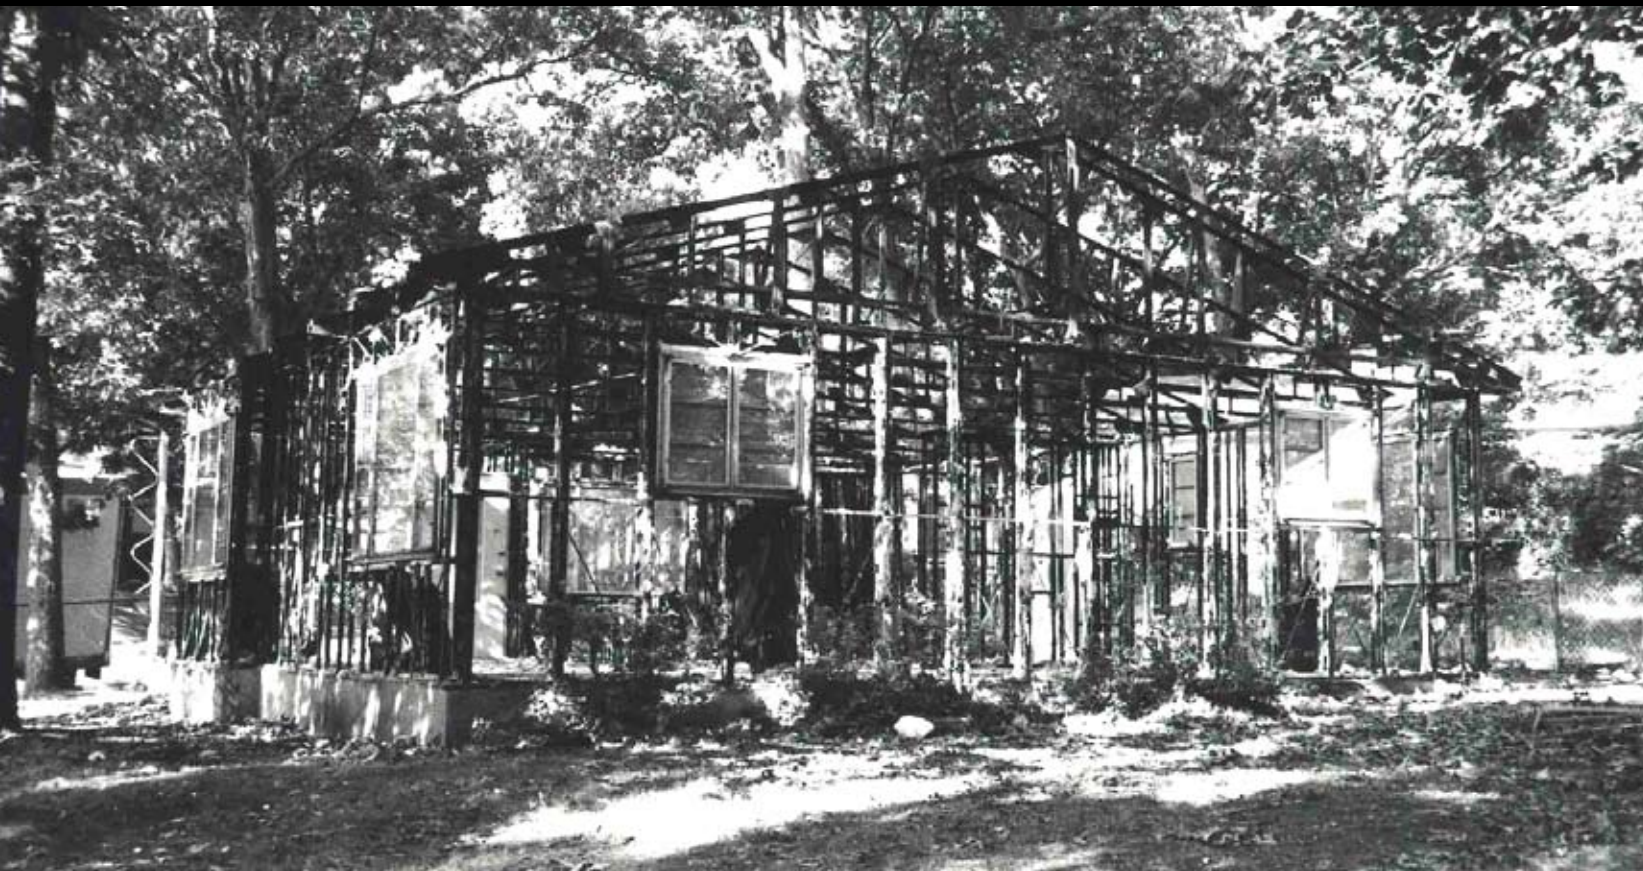
*Only the metal shell remains, looking southwest.
—Cynthia Liccese-Torres, June 6, 2006*
