The Illustrious Lustron

A Guide for the Disassembly and Preservation of
America's Modern Metal Marvel

By
Cynthia Liccese-Torres
and
Kim A. O'Connell

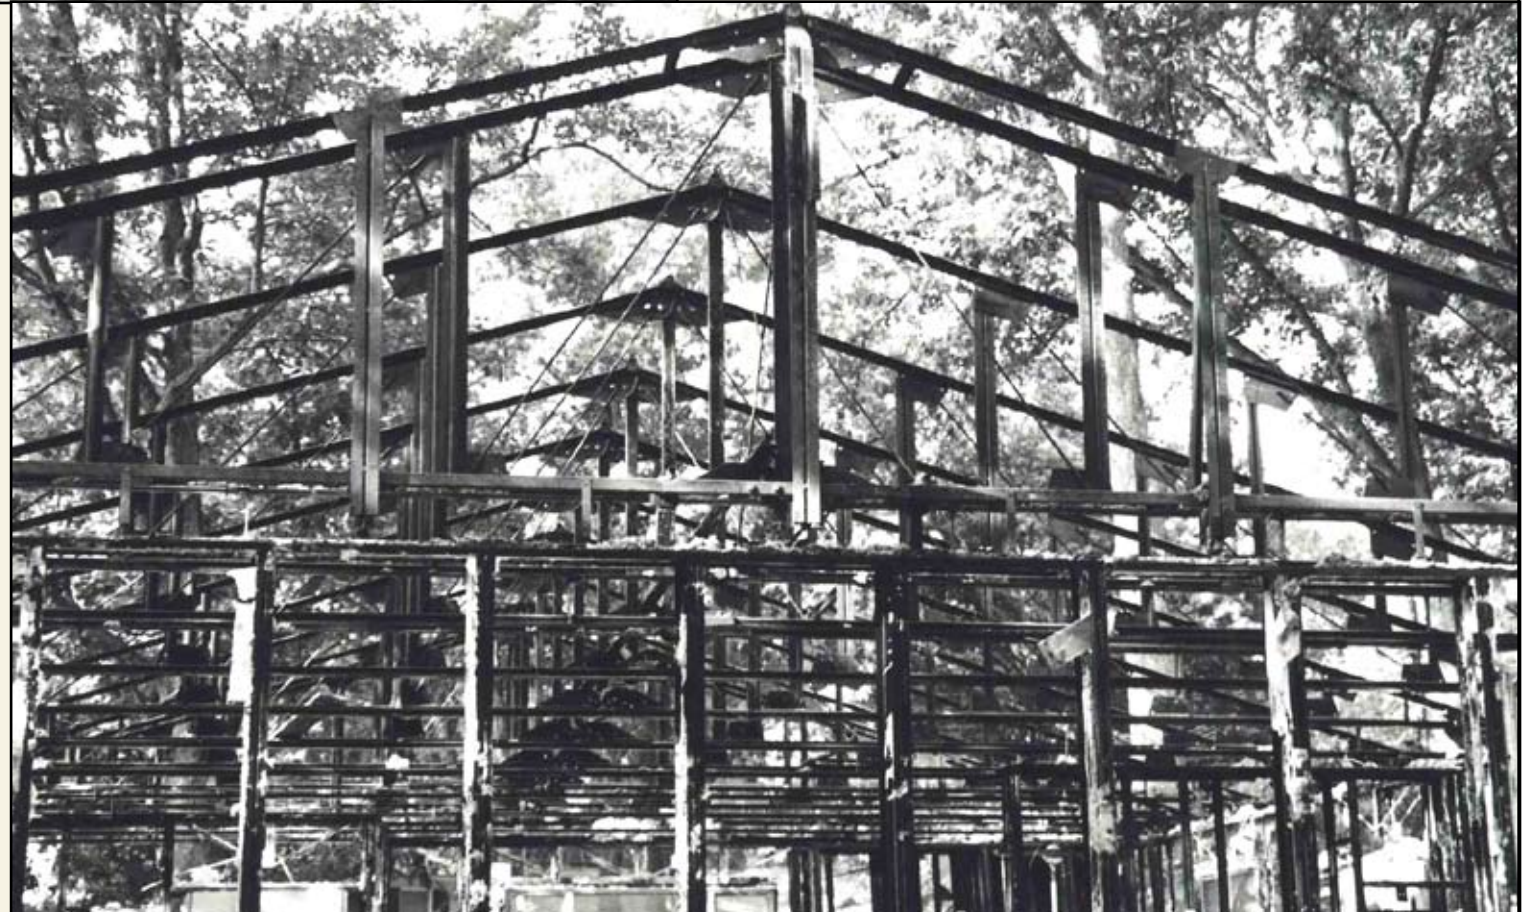
*Detail of roof trussing system, looking south.
—Cynthia Liccese-Torres, June 6, 2006*

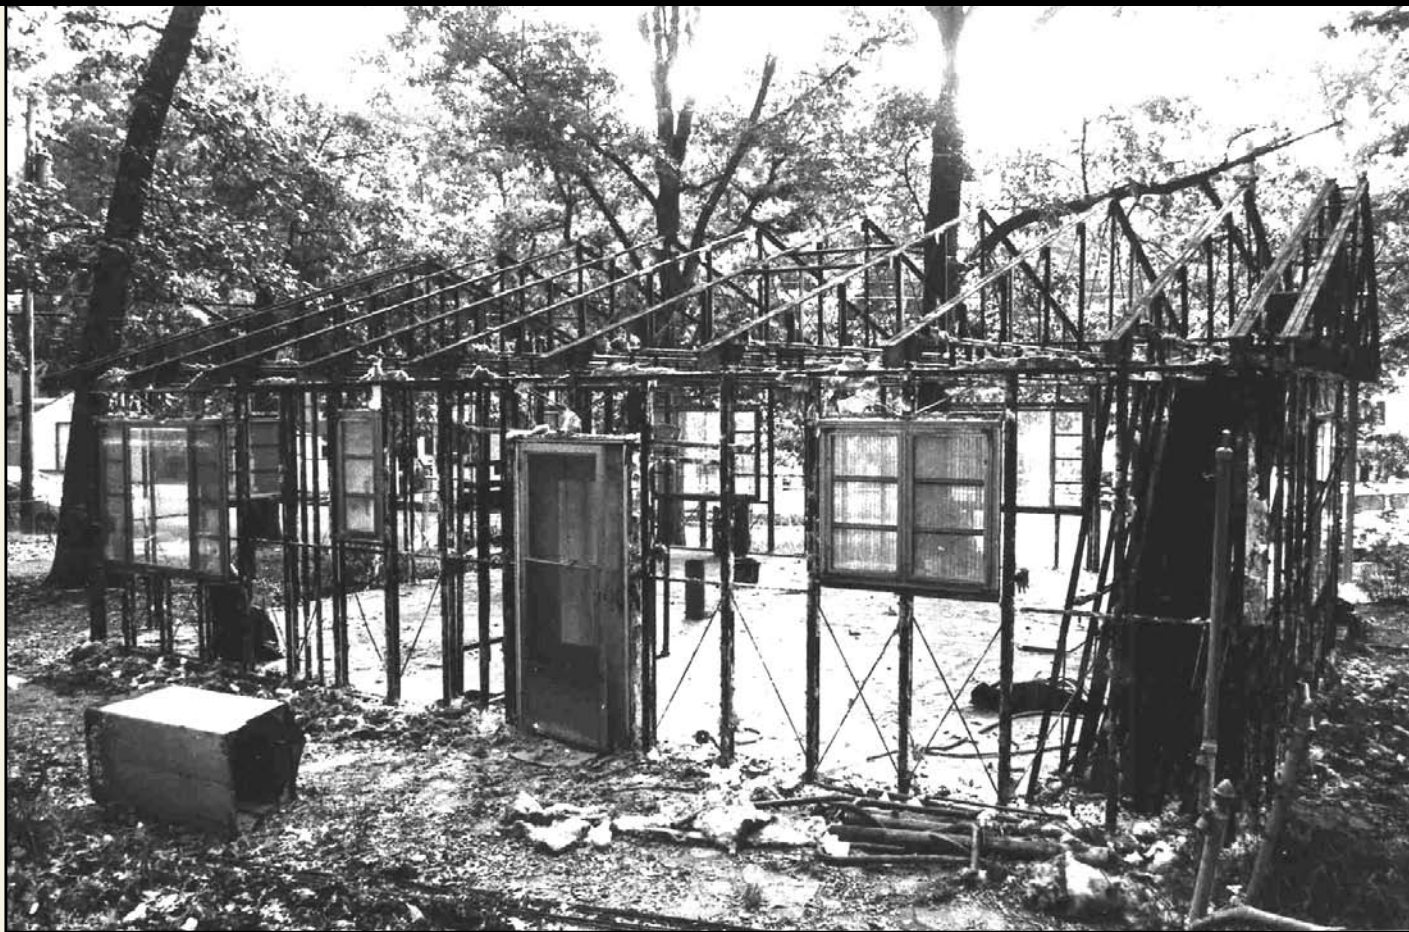
*View of rear (west) elevation, looking east.
—Cynthia Liccese-Torres, June 6, 2006*

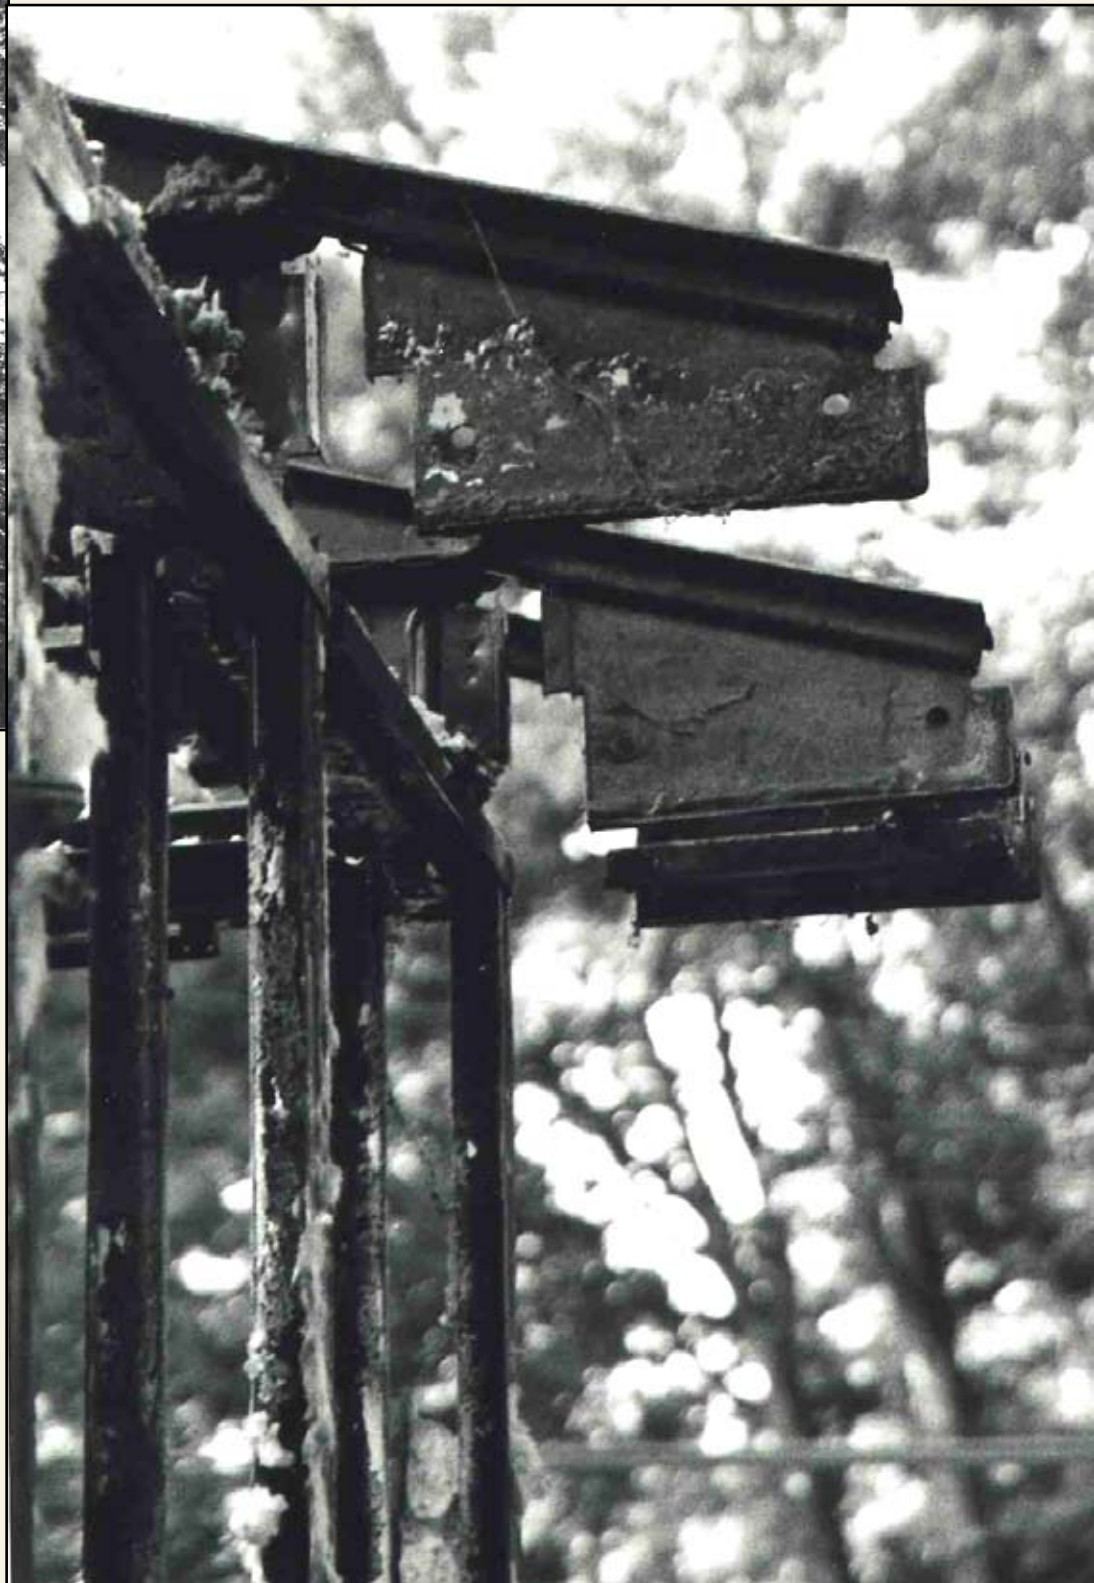
*Detail of ends of roof trusses at southwest corner of house.
—Cynthia Liccese-Torres, June 6, 2006*

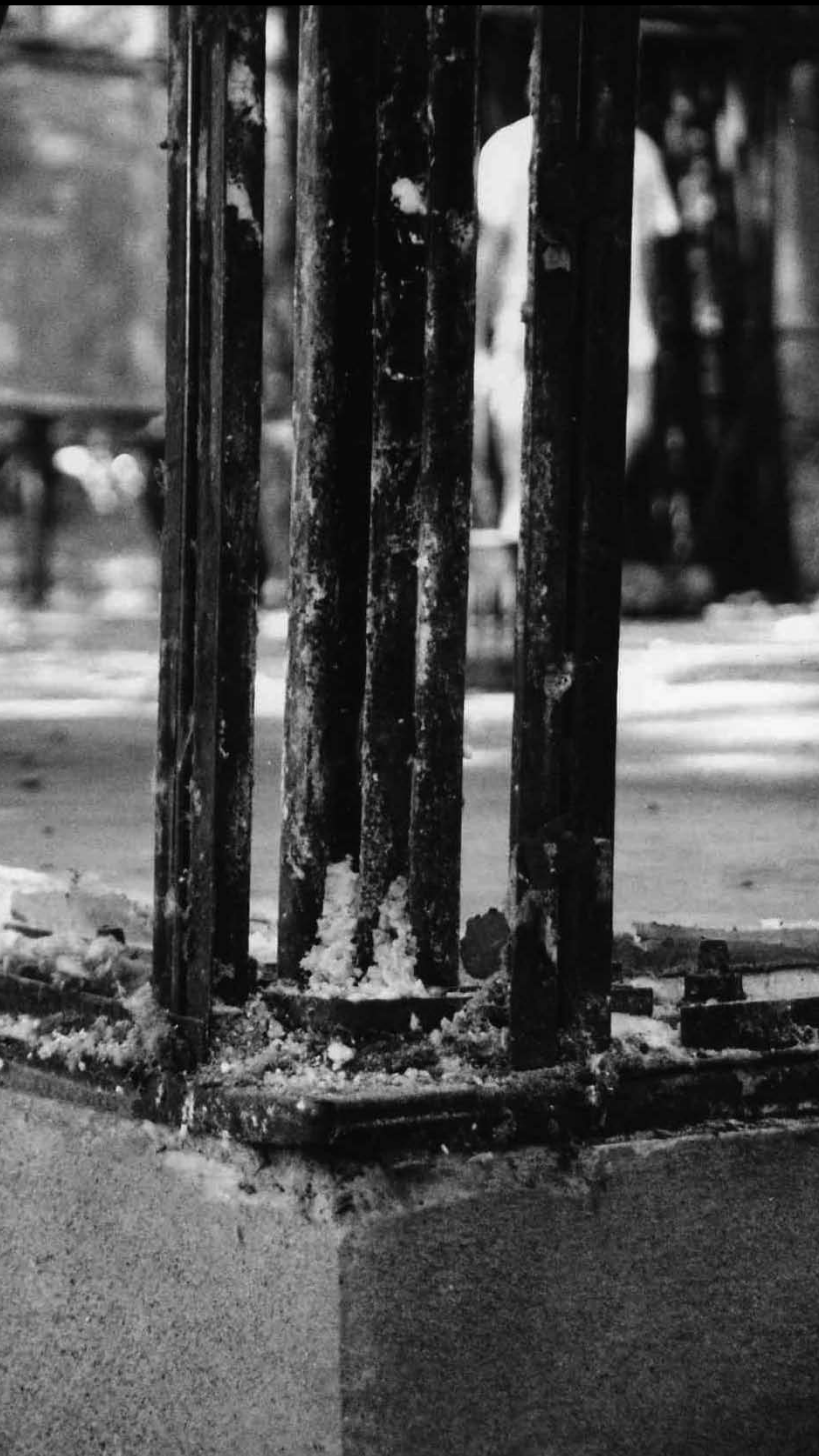
Detail of corner bracing and sill plate; note the large size of the bolt at the bottom right.
—Cynthia Liccese-Torres, June 6, 2006

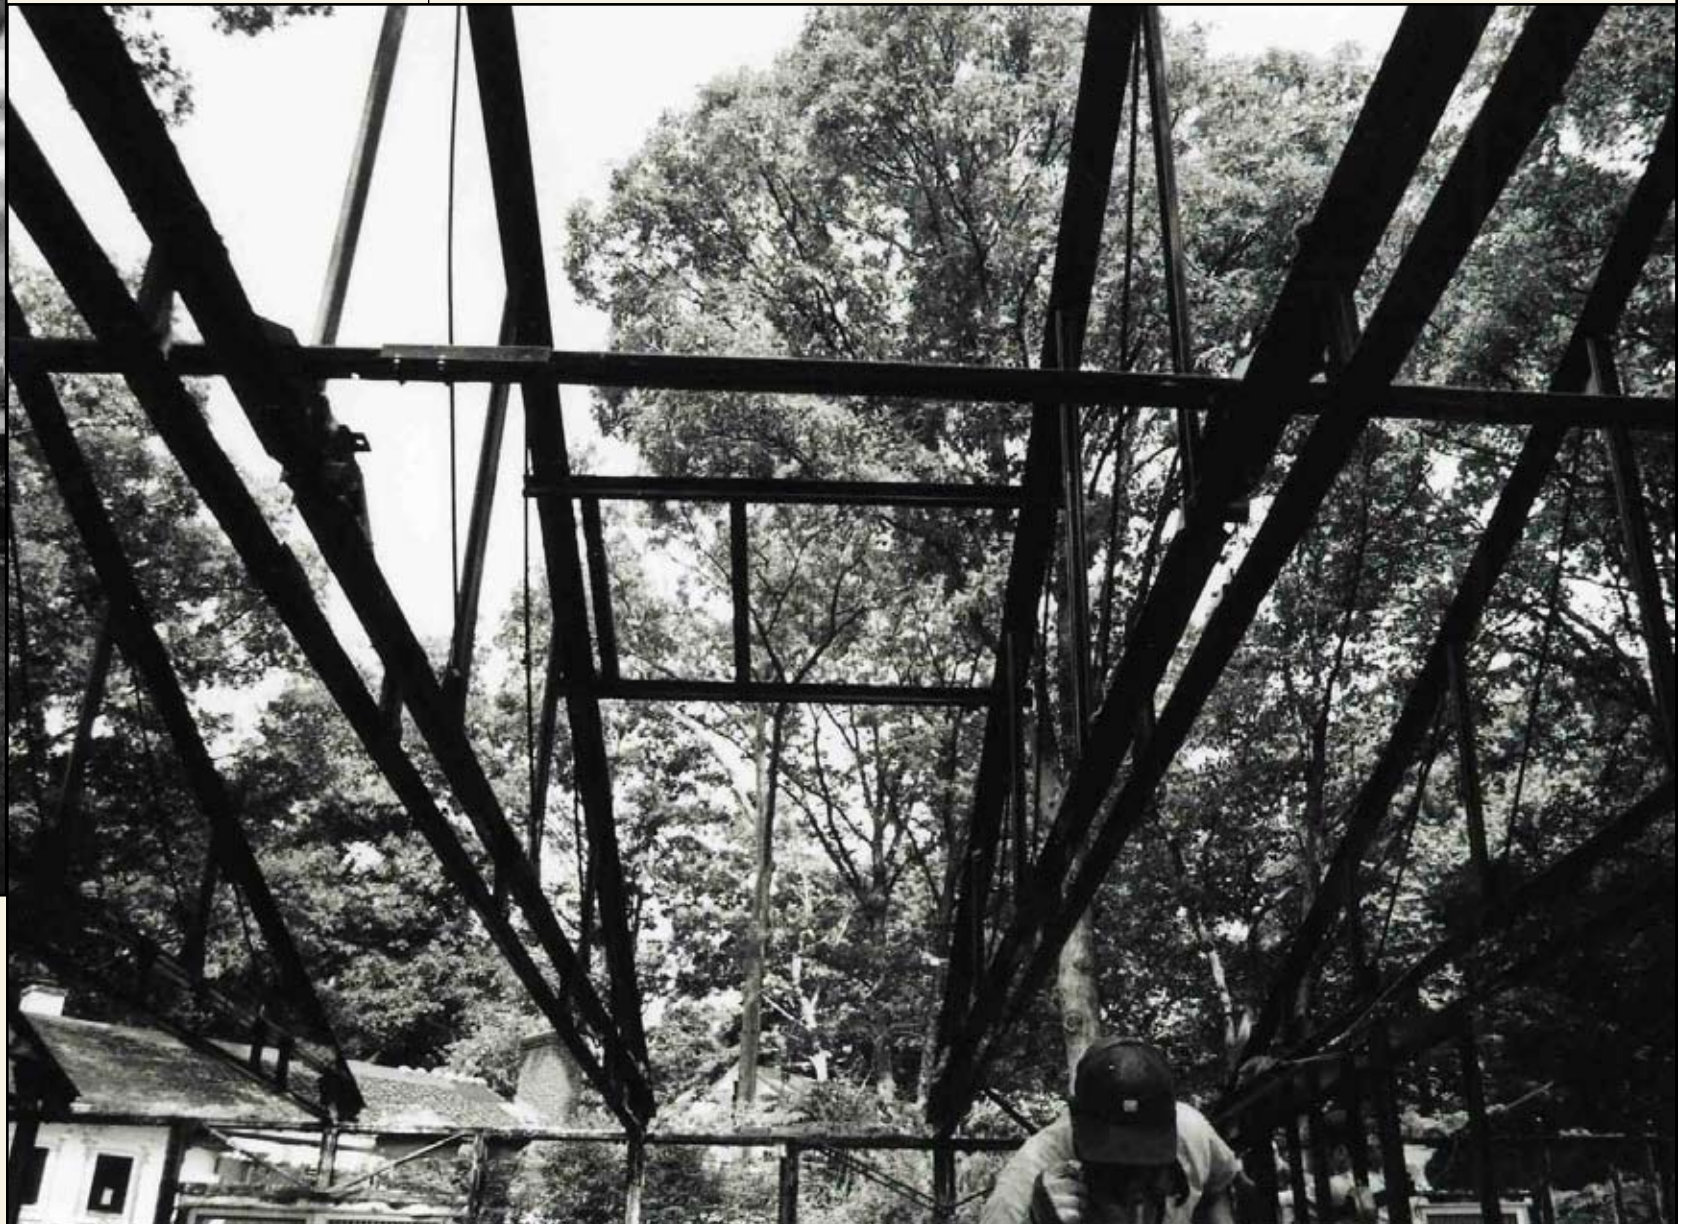
Detail of roof trusses looking up through the roof; note the rectangular opening in the middle for the chimney flue.
—Cynthia Liccese-Torres, June 8, 2006

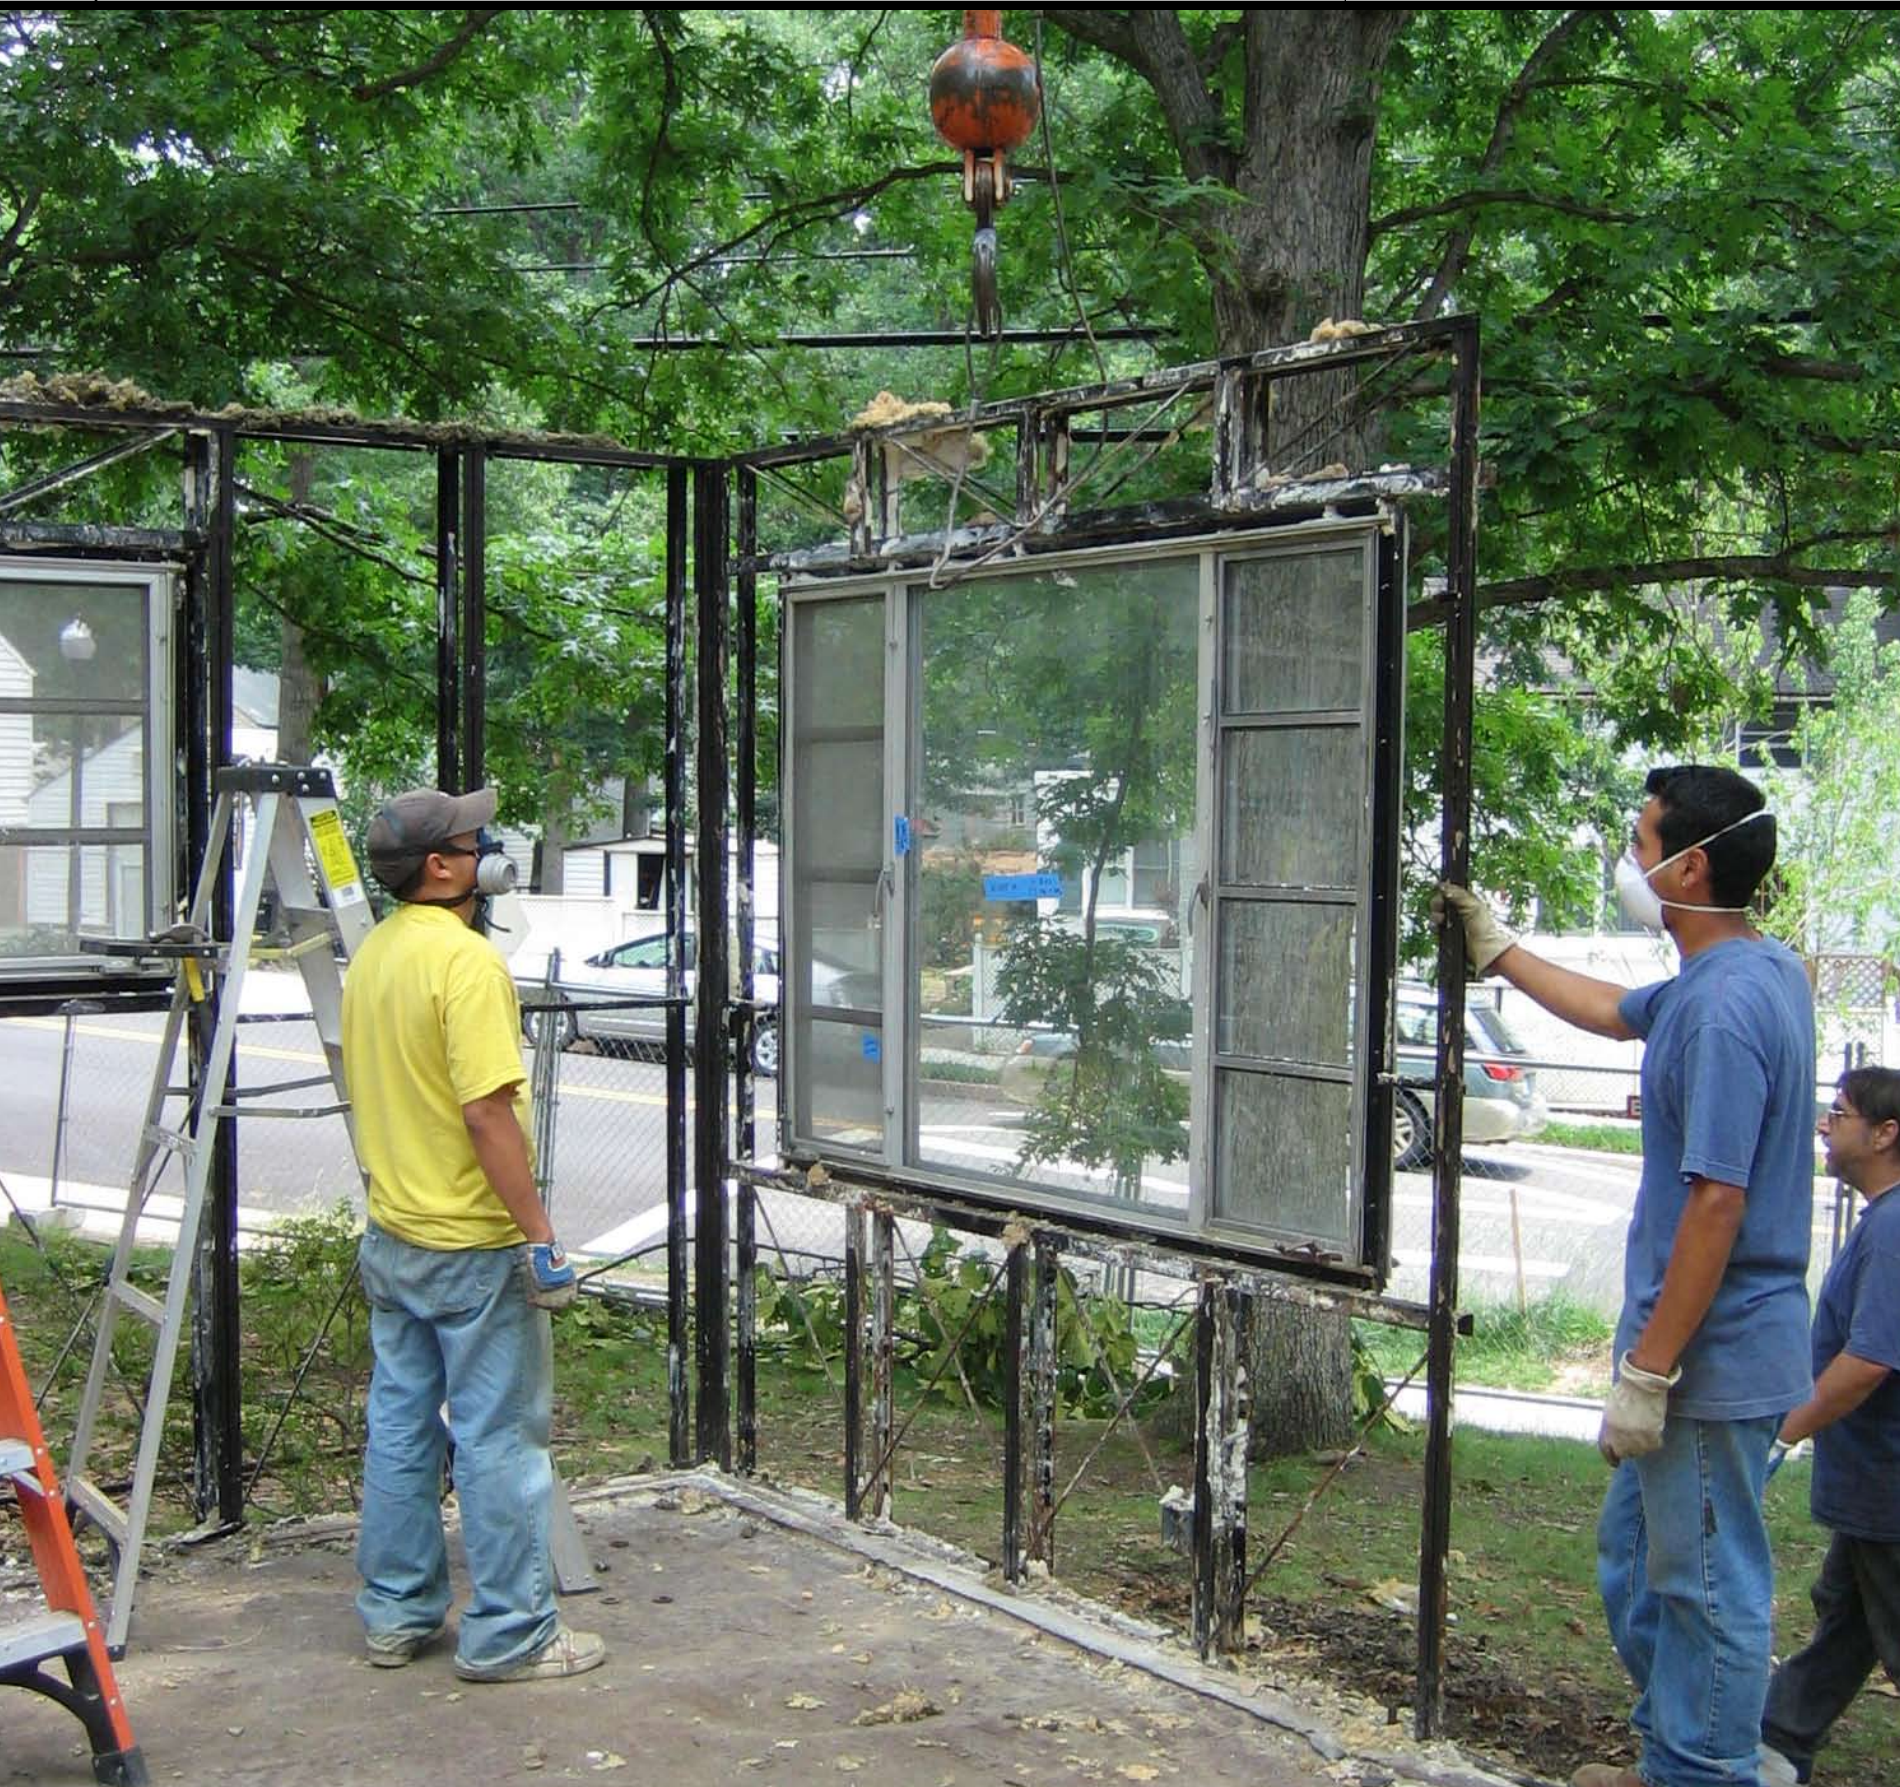
*Removal of the wall sections begins; view of the northeastern corner of the house and the master bedroom's front wall.
—Tom Dickinson, June 8, 2006*

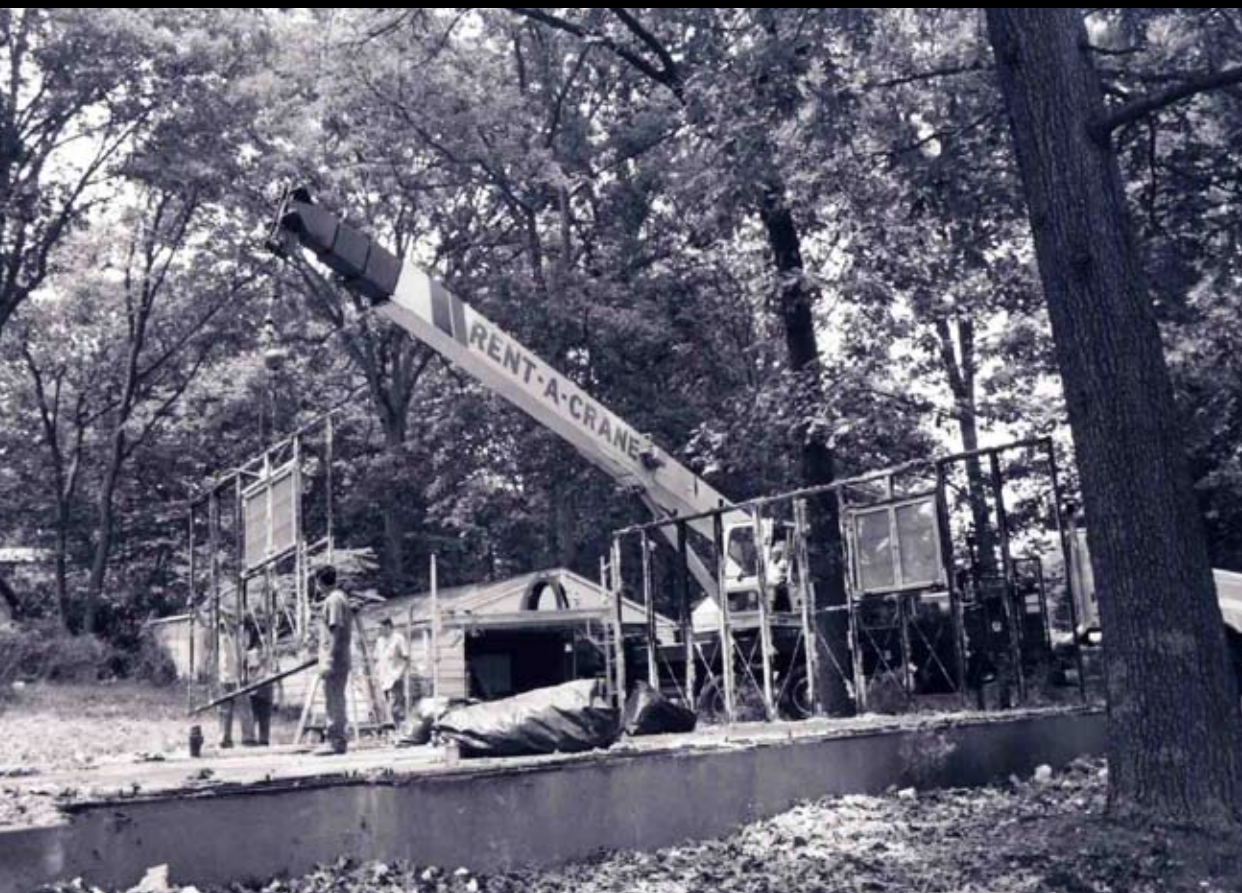
*Removal of the first section of the right (north) wall in the rear bedroom.
—Victor Muniec, June 8, 2006*

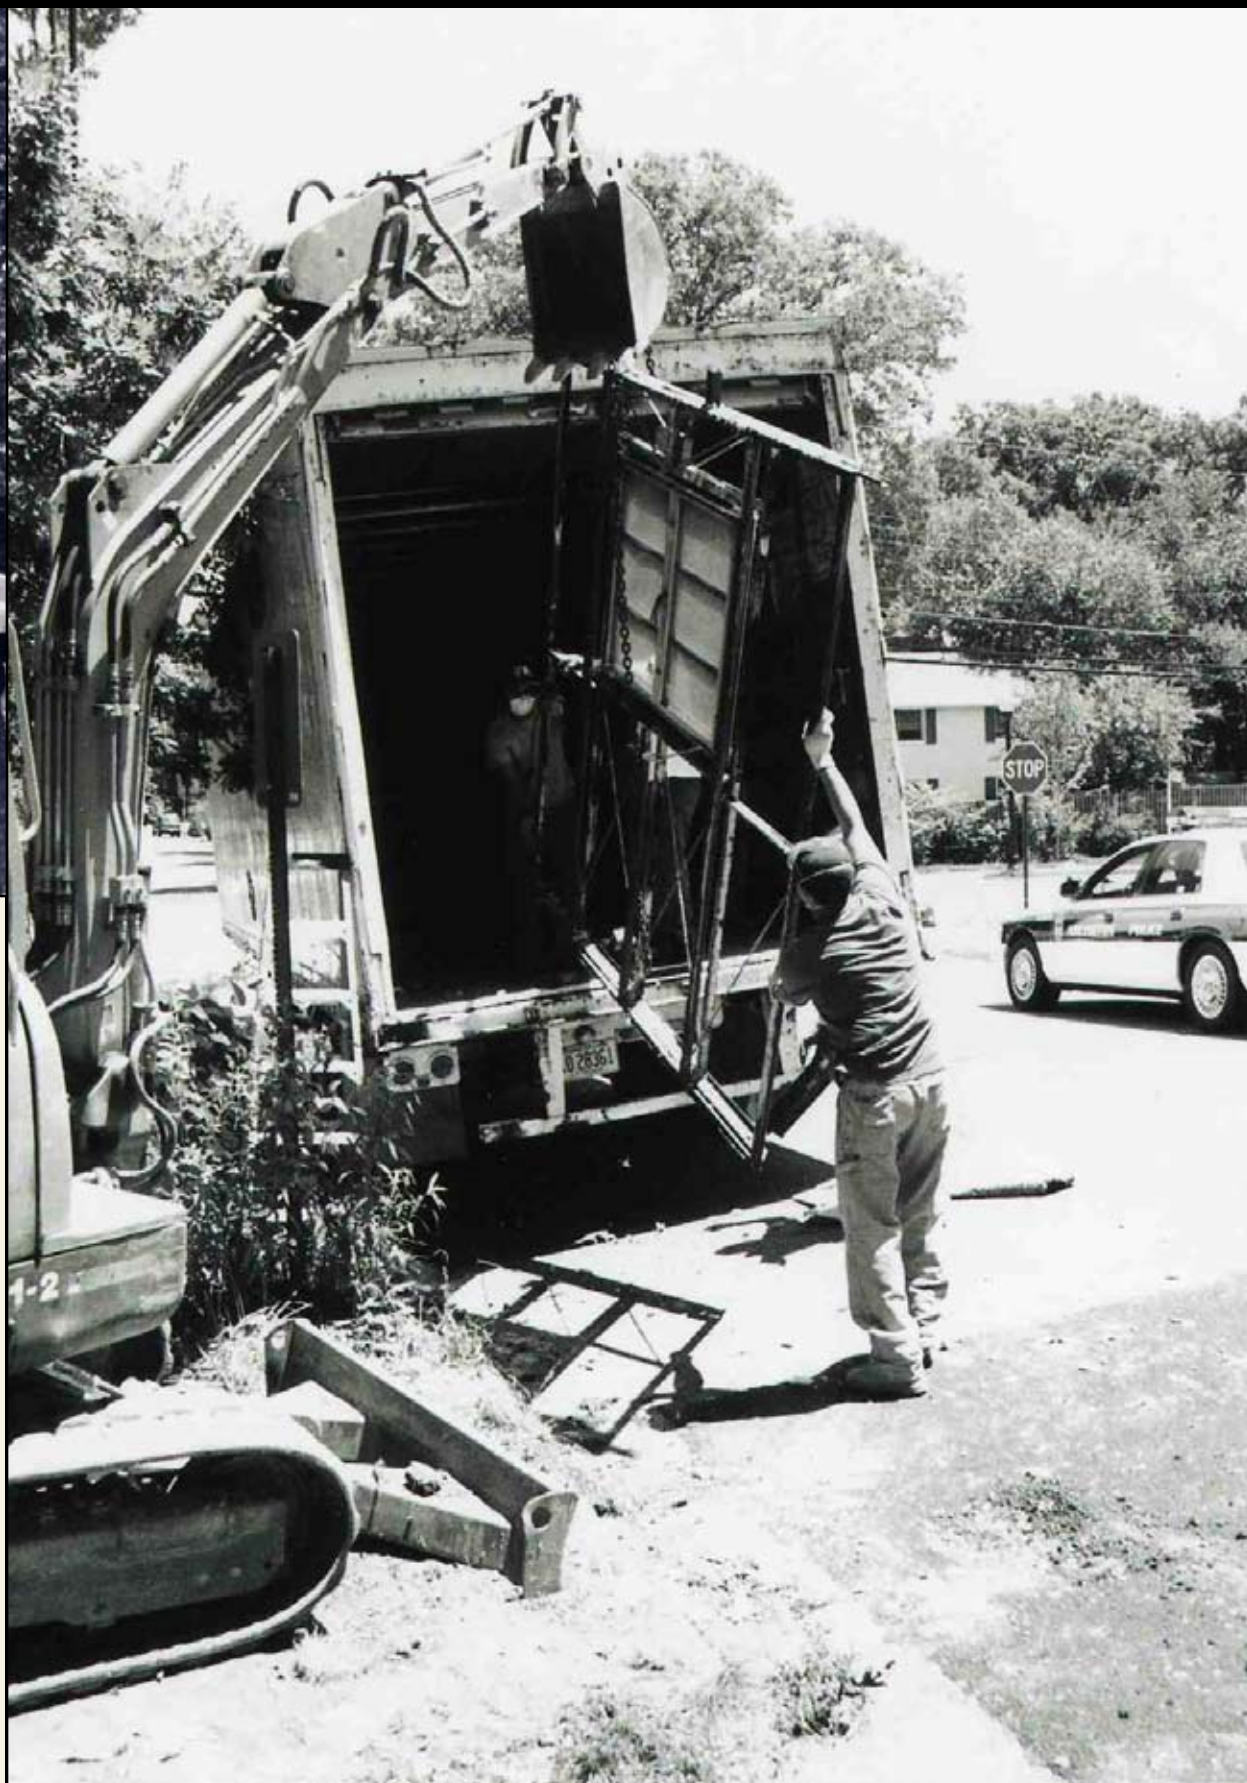
*Maneuvering a wall section into the storage trailer with the assistance of a rented Bobcat.
—Cynthia Liccese-Torres, June 8, 2006*
